Appendix D

***Pilot Basin Study Interim Report
Booker Headwaters Subwatershed***

Pilot Basin Study Report – Booker Headwaters Subwatershed

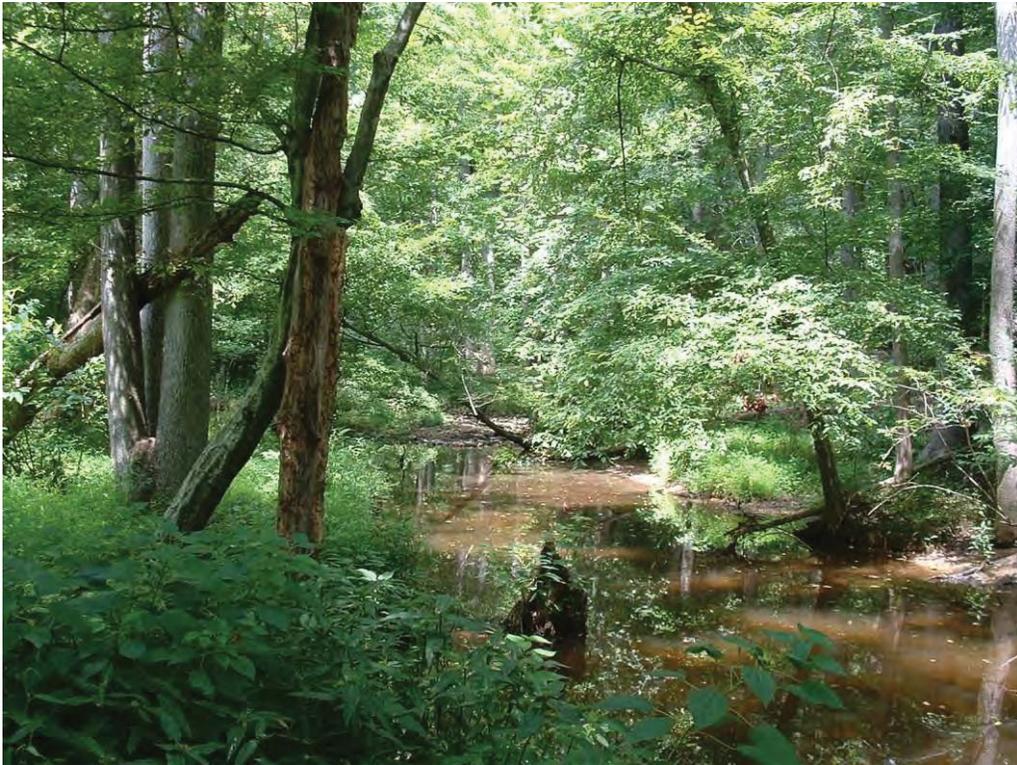
Reach A, the most downstream portion of Booker Creek in this subwatershed, includes the reach from MLK Boulevard to Lake Ellen. It flows through church properties, undeveloped parcels and large residential lots. The riparian areas are forested for almost the entire reach. Some photos of Reach A are shown in Exhibit D-1. There is sedimentation in the downstream portion of the reach in the transition to Lake Ellen. For much of the reach the grade is controlled by bedrock and the stream shows remarkably little sign of negative impacts due to the upstream development.

Downstream end of Reach A

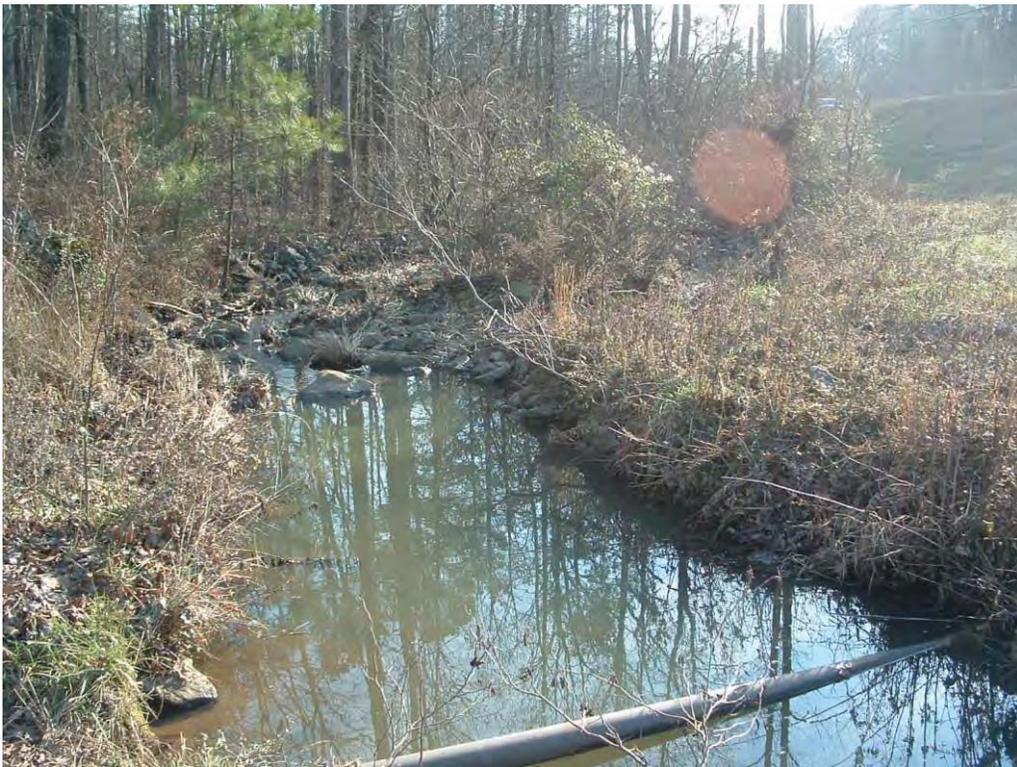
Upstream end of Reach A

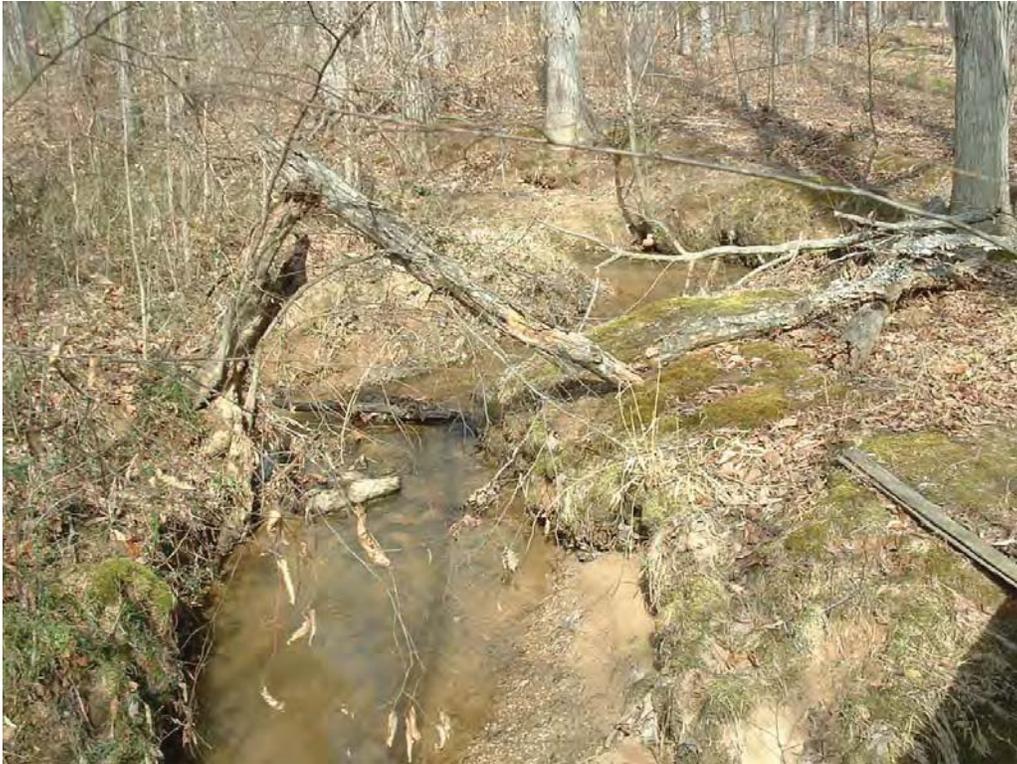
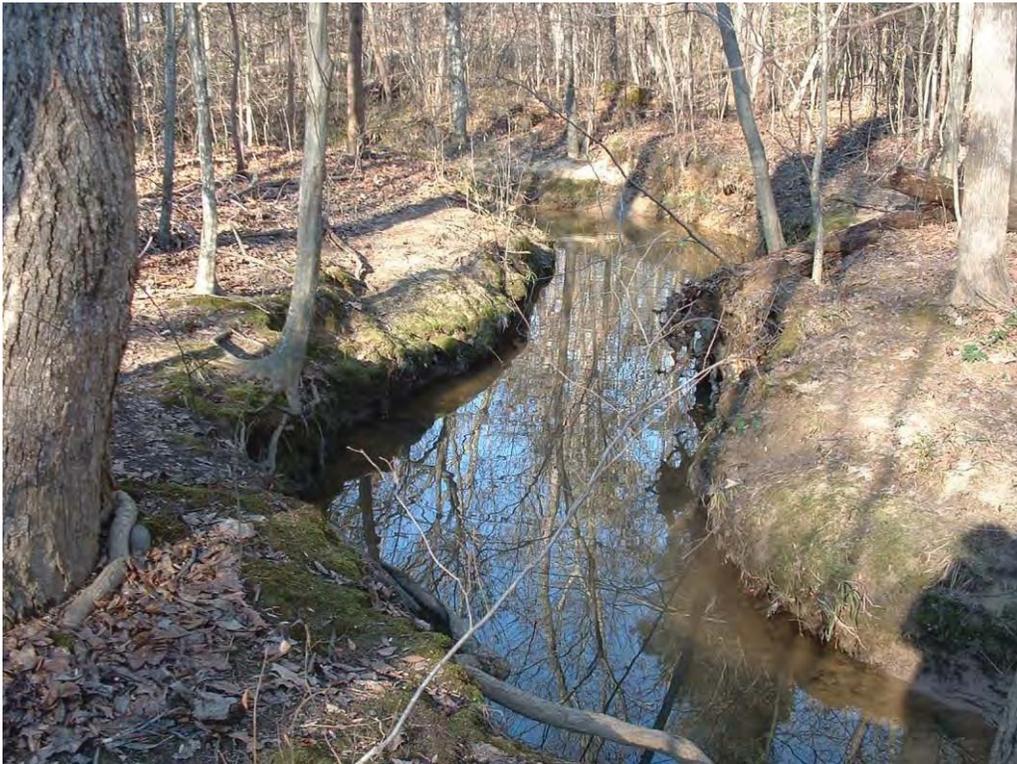
Exhibit D-2. Photos of Reach B in Homestead Park

Reach B, the middle portion of the main stem, is located between New Parkside Drive and MLK Boulevard. Some photos of Reach B are shown in Exhibit D-2. Over half of Reach B flows through Homestead Park. Most of the downstream portion is on the United Church of Chapel Hill parcel, with a small area upstream of MLK Boulevard on a lot owned by NCDOT. The entire reach is crossed only by two trails within the park. The riparian areas are mostly wooded.

The stream condition through this reach is generally good, but is varied and shows early indications of degradation. Some downcutting of the bed seems to be occurring in the downstream portion of the reach, though incision thus far is relatively minimal. Erosion and incision are more pronounced in upper portions of the reach. Sedimentation is evident in some areas along this reach, possibly a result of the relatively recent construction of the park facilities.

A large BMP in Homestead Park on the east side of Booker Creek, apparently constructed as a stormwater wetland, is eutrophic and could be adding instead of removing nutrients. Fertilization of the baseball fields could also be a contributing factor. Algae were persistently evident in Reach B.

1. Install grade control structures at intermediate points along the main stem and tributary 8 to limit downcutting of the stream bed and minimize bank erosion. The structures could be constructed of concrete, gabions, boulders or a combination of materials. Consideration should be given to establishing these points at OWASA crossings and constructing them in a manner acceptable both to OWASA and to TOCH Stormwater Management Division. Grade control structures need to be constructed such that they will remain stable as drop structures should erosion occur on the downstream side. The structures could be installed with Town forces, under a construction contract for a larger project, or as separate projects for a number of structures at different locations. Portions of the stream reaches are within private properties, but much of the stream length requiring grade control is within park and RCD areas owned by the Town.

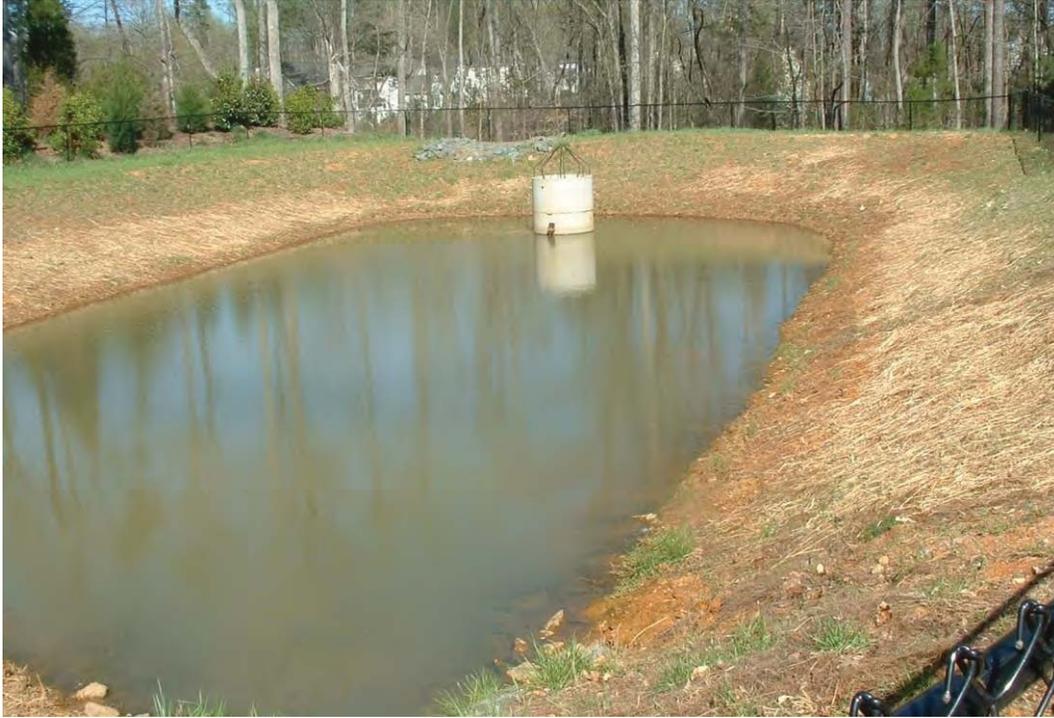
Several BMPs were constructed in conjunction with the park development. There is a large wet pond behind the aquatic center, which appears to be functioning as designed. The aforementioned wetland does not seem to be functioning as intended. There are also a couple of smaller BMPs in the watershed which have not been maintained and for which the design and intended function is not apparent. Pictures of a couple of BMPs are shown in Exhibit D-3.

Wet pond behind aquatic center

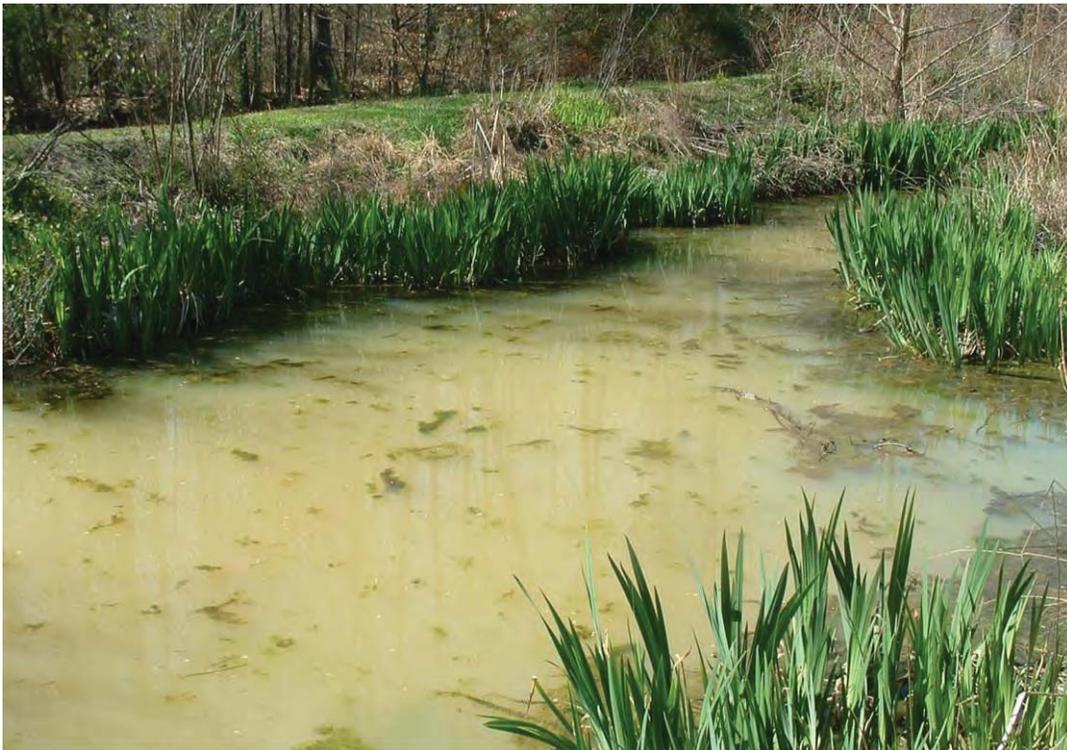
Stormwater wetland near baseball fields

2. Monitor several large existing BMPs and upgrade as needed. TOCH should consider seeking grant funding to monitor and potentially upgrade up to four relatively large BMPs in this subwatershed: the large bioretention facility at the apartment complex on Tributary 3, the stormwater wetland draining the baseball field in Homestead Park, the wet pond draining the aquatic center and parking area in Homestead Park and the wetland draining the apartment complex on Tributary 8. The additional assessment of these facilities in regard to nutrient removal would enhance the Town's (and the State's) knowledge of how well recently designed and installed BMPs are functioning relative to the Jordan rules. Monitoring from several storms over the course of the year should provide sufficient information on which to base plans for improvements to the BMPs and/or changes to ordinances or design guidance. Improvements to the BMPs should be undertaken if the data indicates that inadequate nutrient removal. Changes may include soil media replacement, vegetation changes, grading changes and replacement of outlet structures. For the privately owned BMPs, the Town would have to fund the desired improvements and would have to obtain agreements from property owners and possibly also easements.

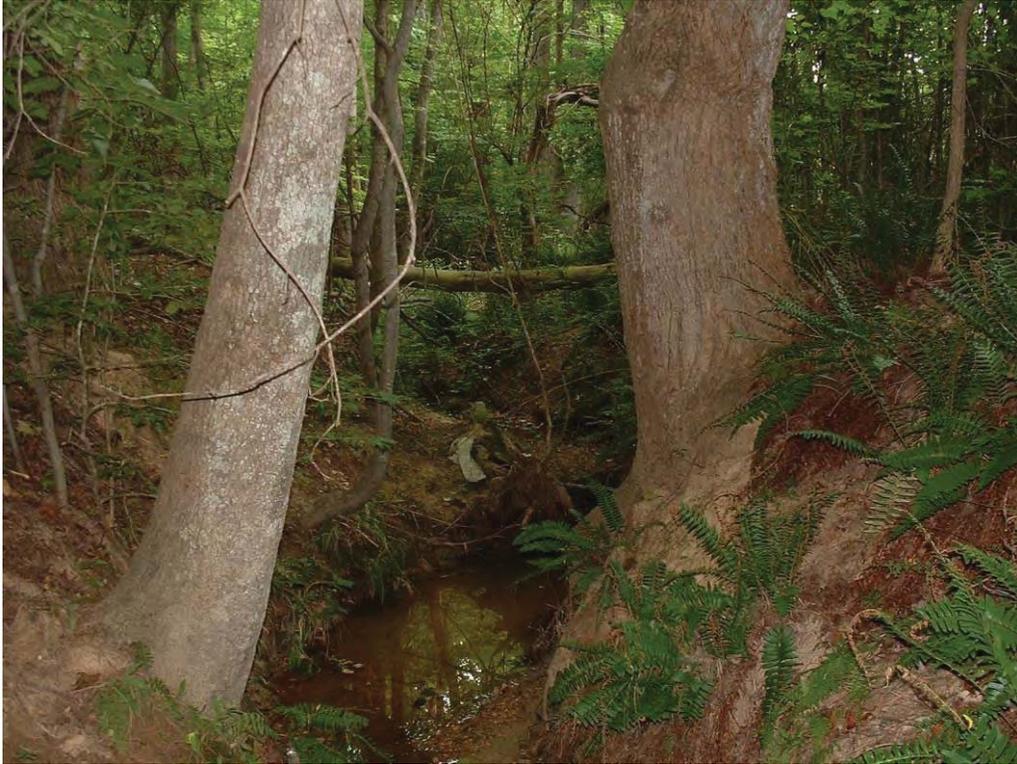
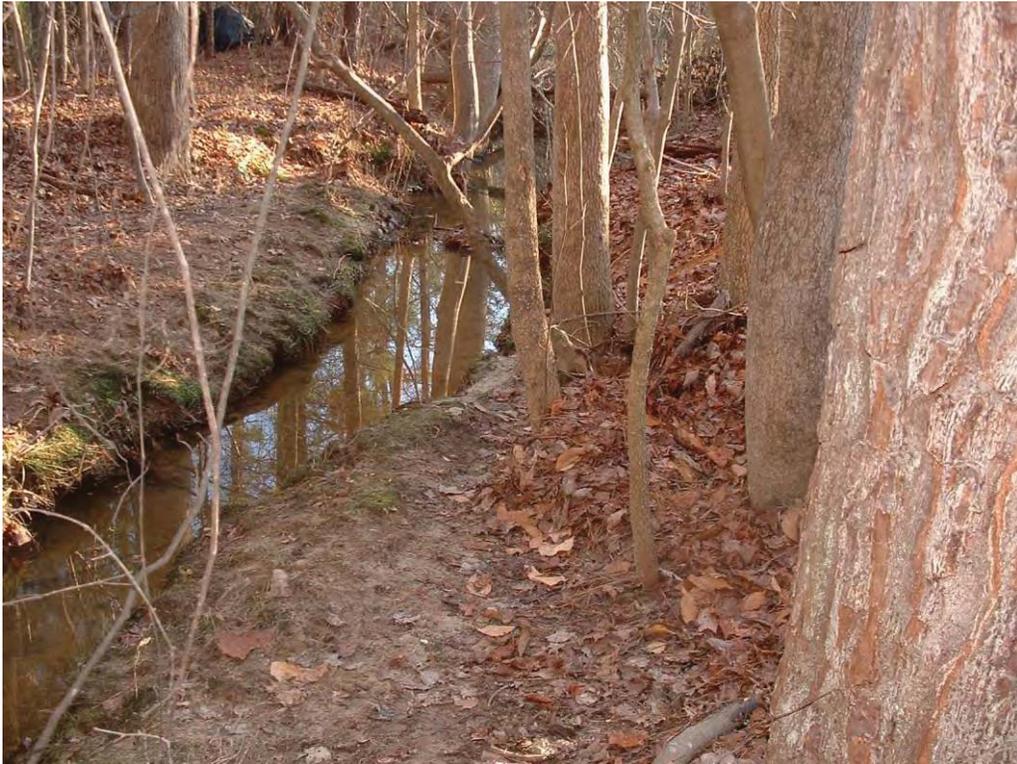
Exhibit D-4. Photos of Reach C, Booker Headwaters

Reach C, from Weaver Dairy Road to New Parkside Drive, is the most upstream reach of Booker Creek. Some photos along the reach are shown in Exhibit D-4. Development has occurred along the entire reach, drastically changing the hydrology and hydraulics of the catchments. A dozen pipe systems discharge into the RCD area along Reach C. Several tributaries have numerous road crossings and/or extensive pipe systems. However, RCD requirements have preserved a wooded buffer along Reach C that is at least 100 feet wide at all points. The only crossings along the main stem are OWASA pipeline aerials or access crossings.

Headcuts seem to be migrating upstream through a couple of relatively flat, shallow floodplain areas where there was little evidence of a single, low-flow channel at the time of the field observations in spring 2009. One of these locations is in the area of an OWASA crossing, where the main stream channel could not be discerned during the April visit. The entire crossing is grassed, with water flowing across in numerous shallow areas such that the location of the main low flow channel could not be definitely discerned. On the 1977 soil survey, this area is mapped as having two streams, with the longer reach discharging to what is now mapped as Tributary 9 and the shorter picking up the discharge from Tributary 10. It seems likely that the OWASA crossing, in combination with the line paralleling the creek, significantly altered the routing of flows through this area and has resulted in the observed instabilities. At some distance downstream of the crossing, there are multiple small drainage channels with headcuts. It is difficult to discern what the natural condition of the area would be without the crossing. A similar area exists further upstream where there is no OWASA crossing. In between the two flat areas, as well as upstream and downstream, there is clear evidence of ongoing channel incision. At one location, a homeowner had constructed a small dam in the creek to create a reservoir for pumping water to facilitate his backyard landscaping project. Reach C is unstable and is likely to experience continuing erosion until a new stream equilibrium is established.

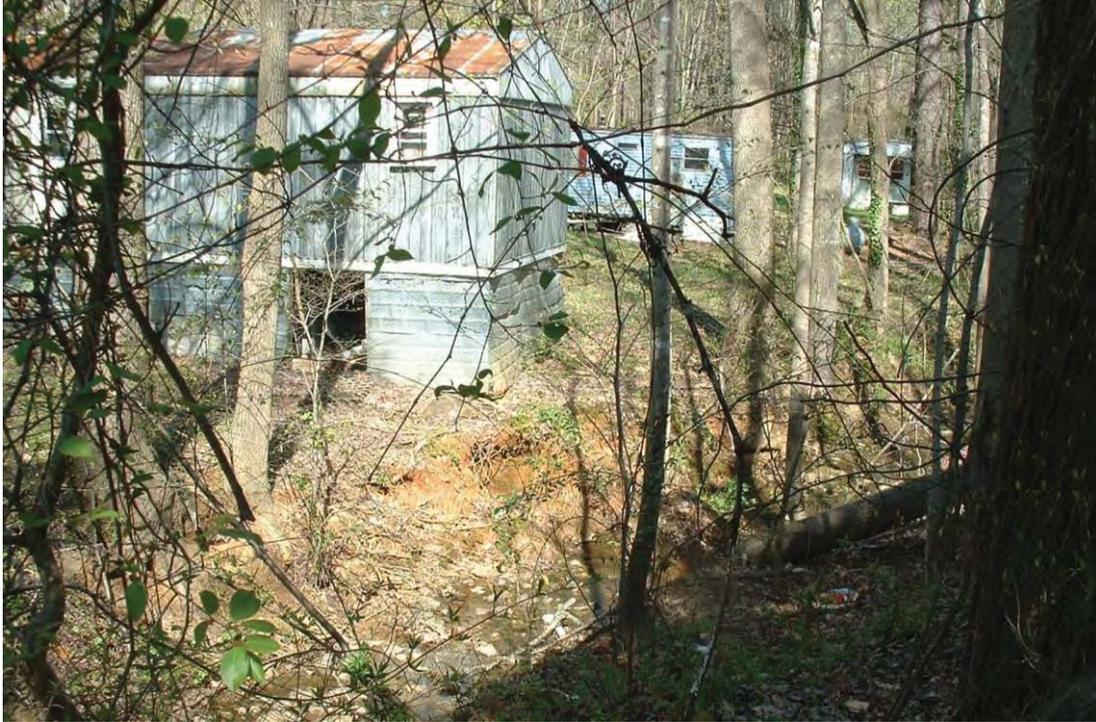
Mobile home close to the bank of Trib 3

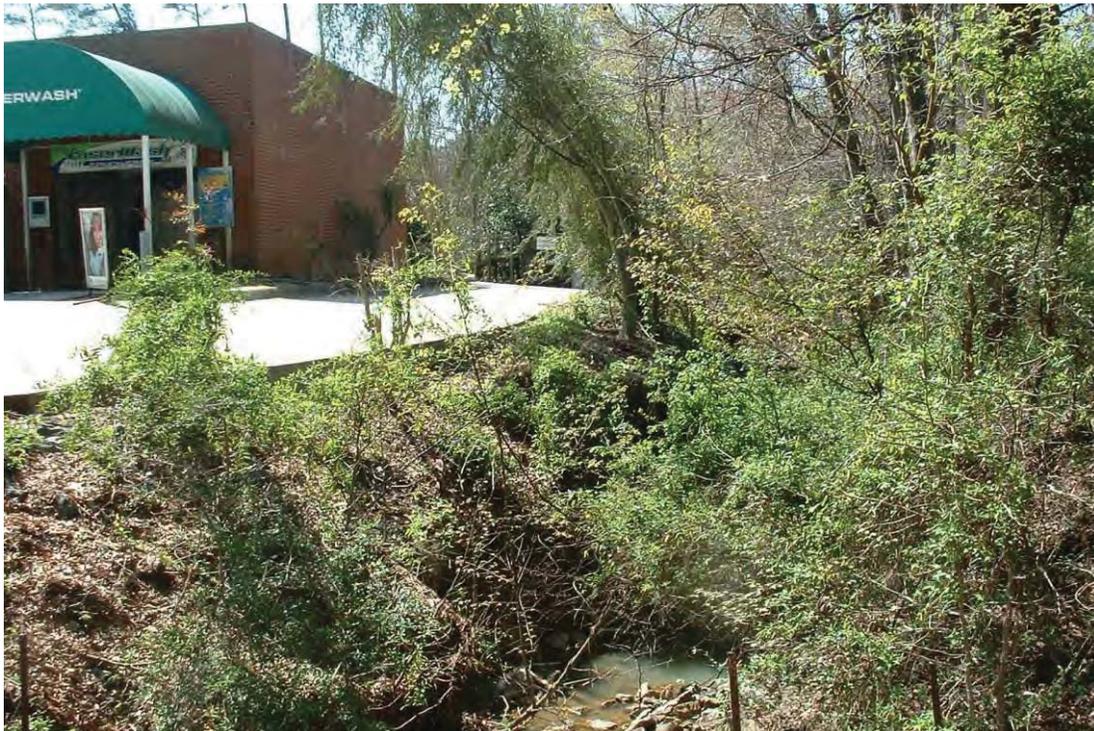
Developed properties within the subwatershed include several with potential to contribute particular pollutants to the nearby streams. A car wash is operated in close proximity to Tributary 3. A large automobile repair facility is operated in the same vicinity, with roughly 50 cars parked there at any given time, many of them apparently junked or stored long term. A training area for the Town's fire department is located near Tributary 12. Improperly routed or managed runoff from these types of facilities can result in pollutant discharges to adjacent streams.

Carwash with paving to the bank of Trib 3

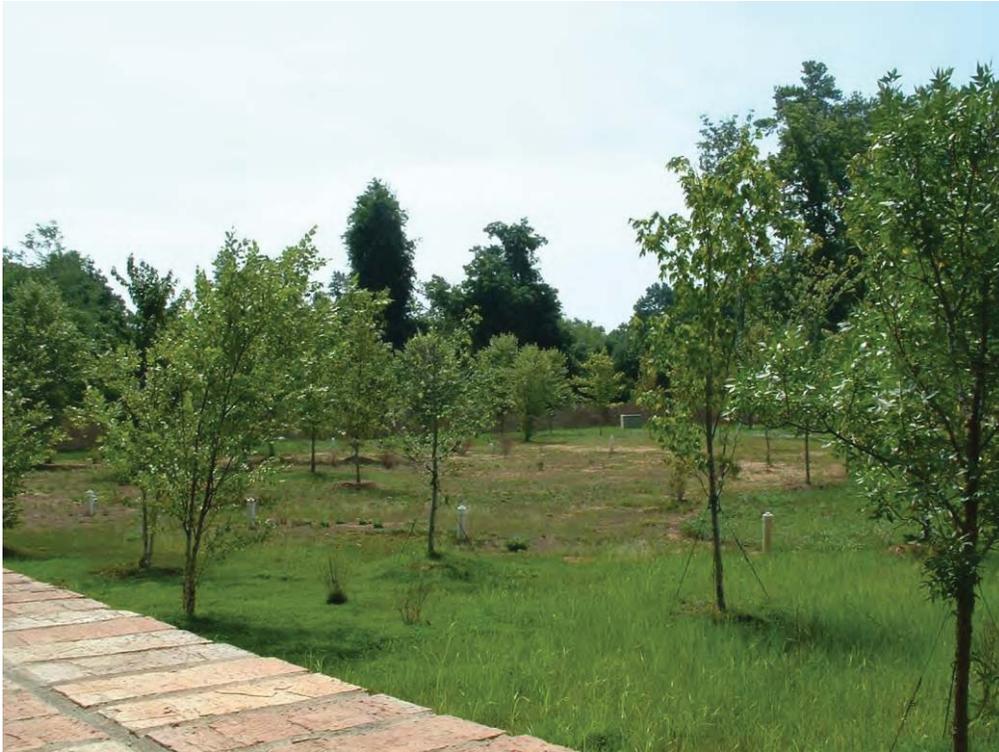
One of the apartment complexes in this area has a large bioretention BMP. The complex drains to a walled-in area encompassing about 7/10 acre, where runoff ponds and is infiltrated, partially collected in underdrain piping, and discharged through 2-36” pipes to the north branch of Tributary 3. The vegetation appears to be relatively sparse and the depth of the infiltration media is not known. The BMP is fenced and has a controlled access gate. The area is presumed to be accessible to residents of the complex. TOCH Stormwater staff requested from the property owners, but have not received, additional information on the design and function of the BMP. The BMP and the Tributary 3 reach downstream are shown in Exhibit D-6.

Bioretention BMP

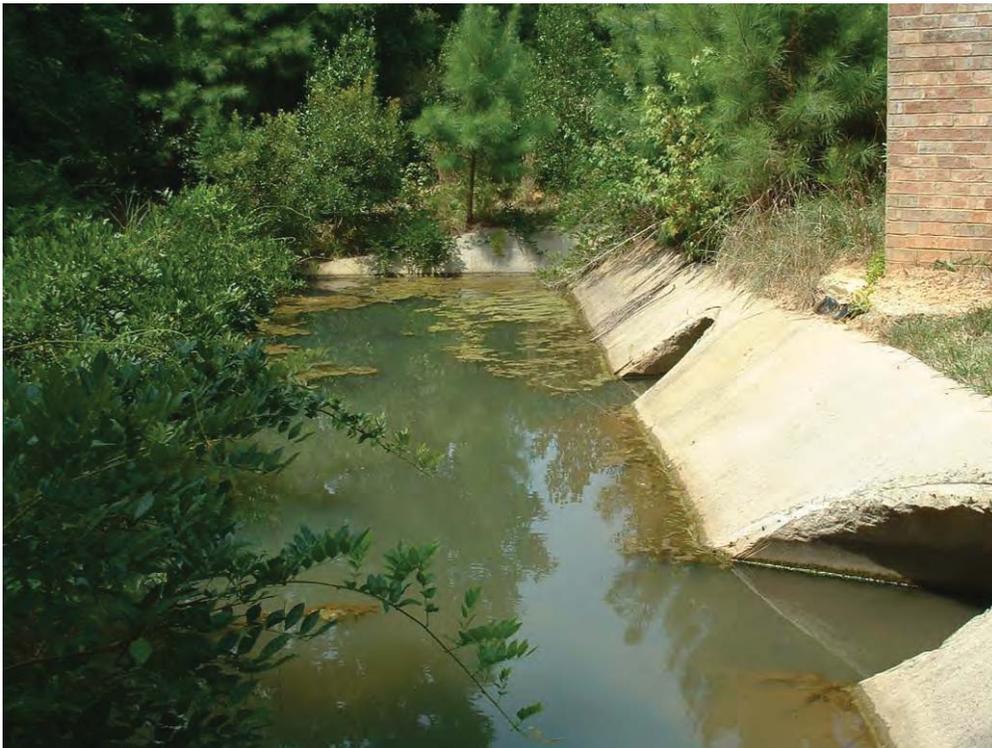
BMP discharge area

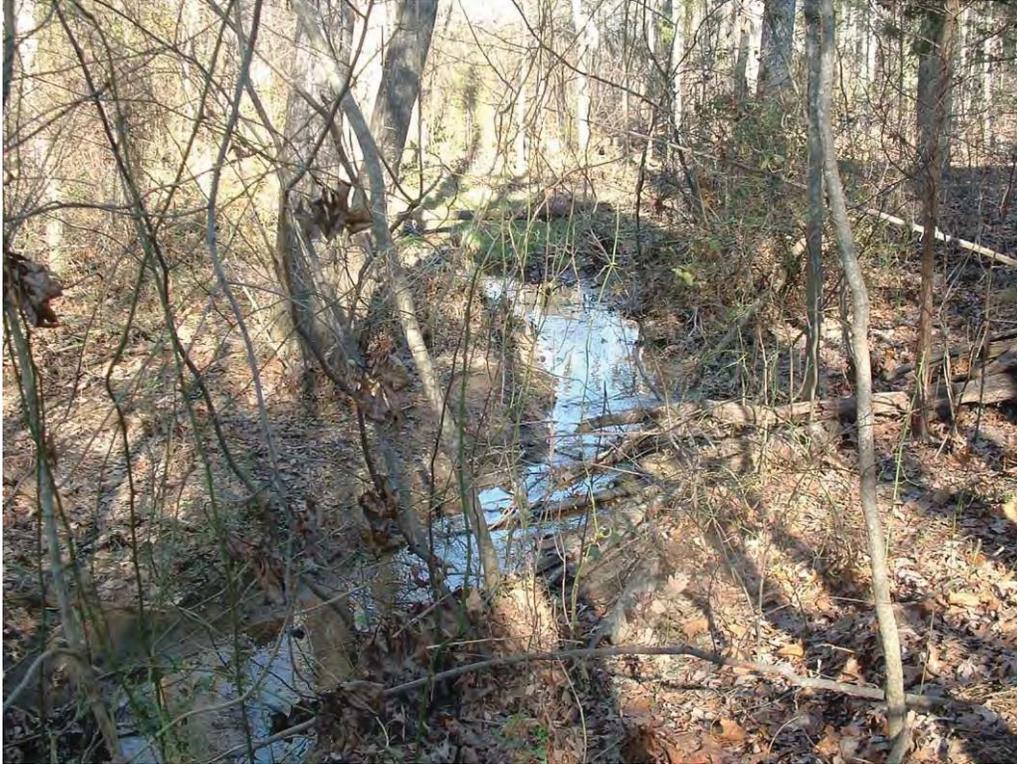
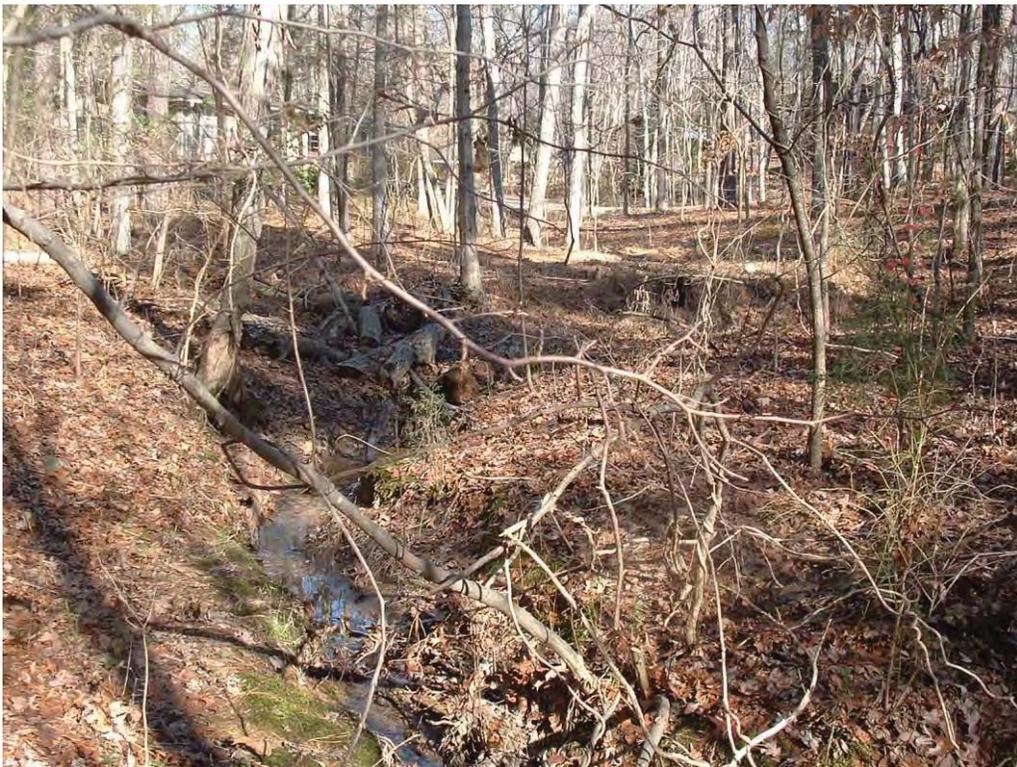
Exhibit D-7. Photos of Stream Reaches on Tributary 7

All reaches observed on Tributary 7 and its subtributaries exhibit good geomorphological conditions, with the exception of some encroachments in residential areas, such as a footbridge, driveway and road crossings and a few riparian areas cleared for grass or gardening. Very little incision has occurred and the streams are generally shallow and well-connected to adjacent floodplain areas. Some photos on Tributary 7 are shown in Exhibit D-7.

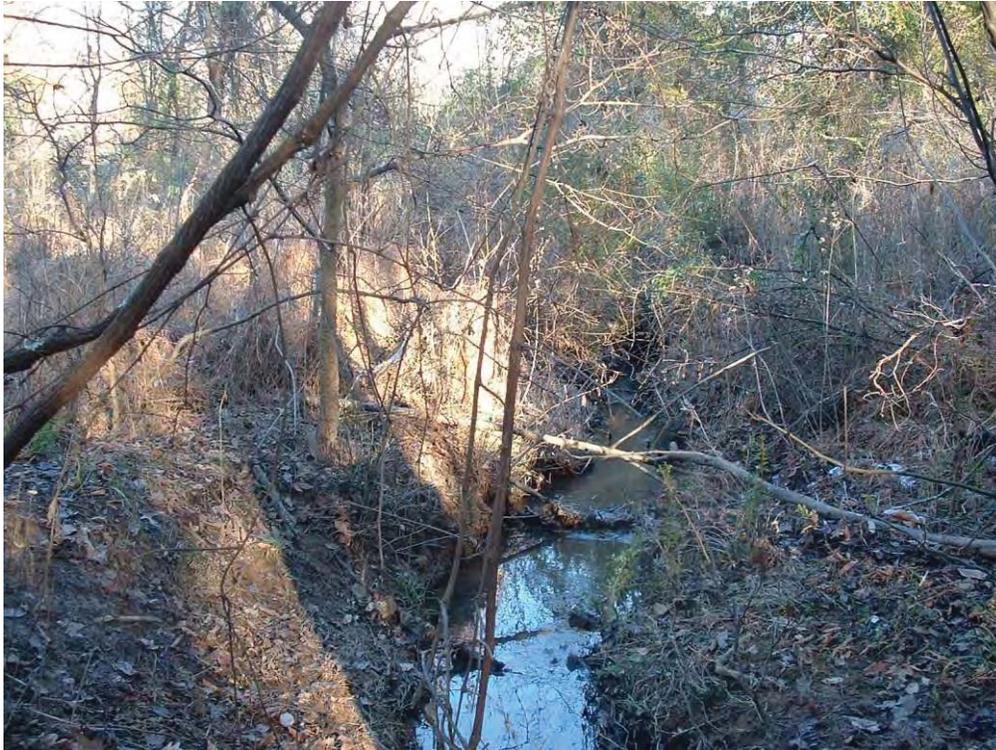
Stream conditions along Tributary 8 are mixed. A few portions of the stream are somewhat incised, while most reaches seem to have retained a good connection with the surrounding floodplain area. The conditions at the upstream end of the Weaver Dairy Road culvert are particularly odd. Silt fence has been left in place about six to ten feet upstream of the culvert entrance. Sediment and large gravel have accumulated in the area between the fence and culvert

Tributary 8 reach between Homestead Park Road and driveway crossing

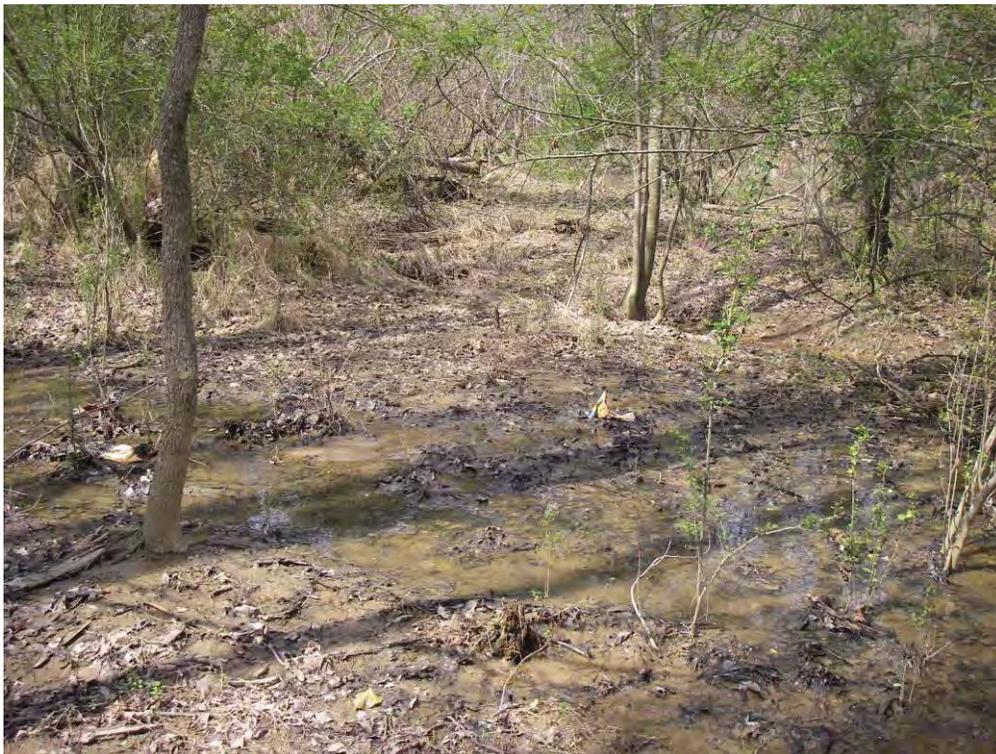
Area on Tributary 8 upstream of driveway crossing and Tributary 8A confluence

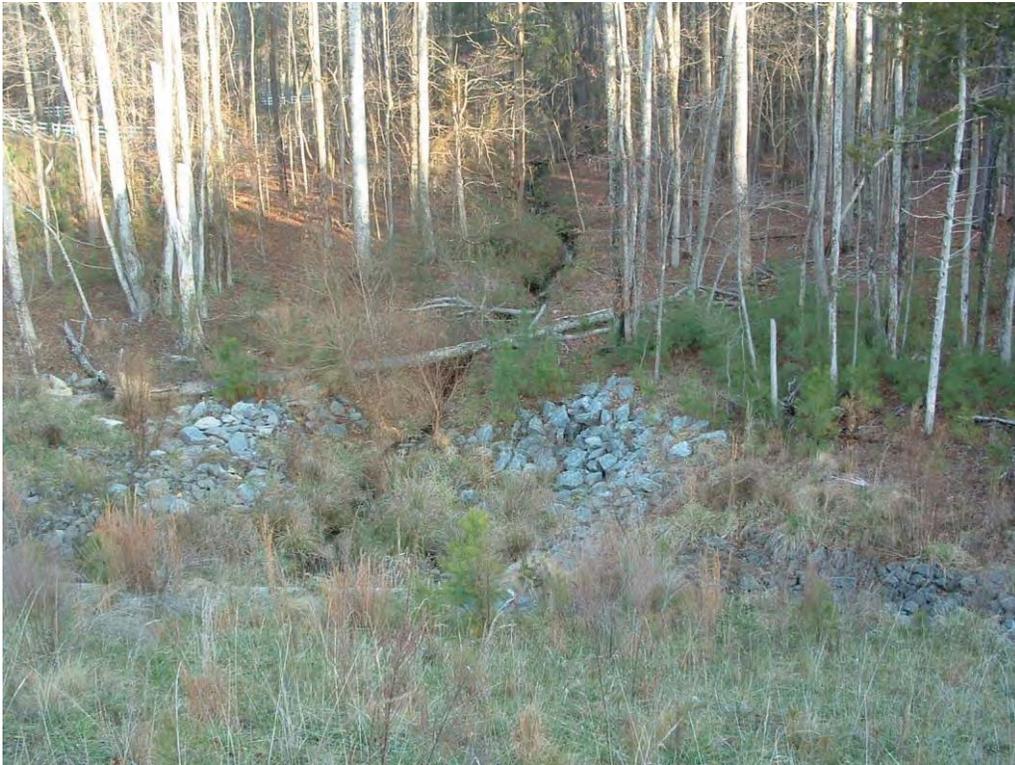
Tributary 8 downstream of Weaver Dairy Road

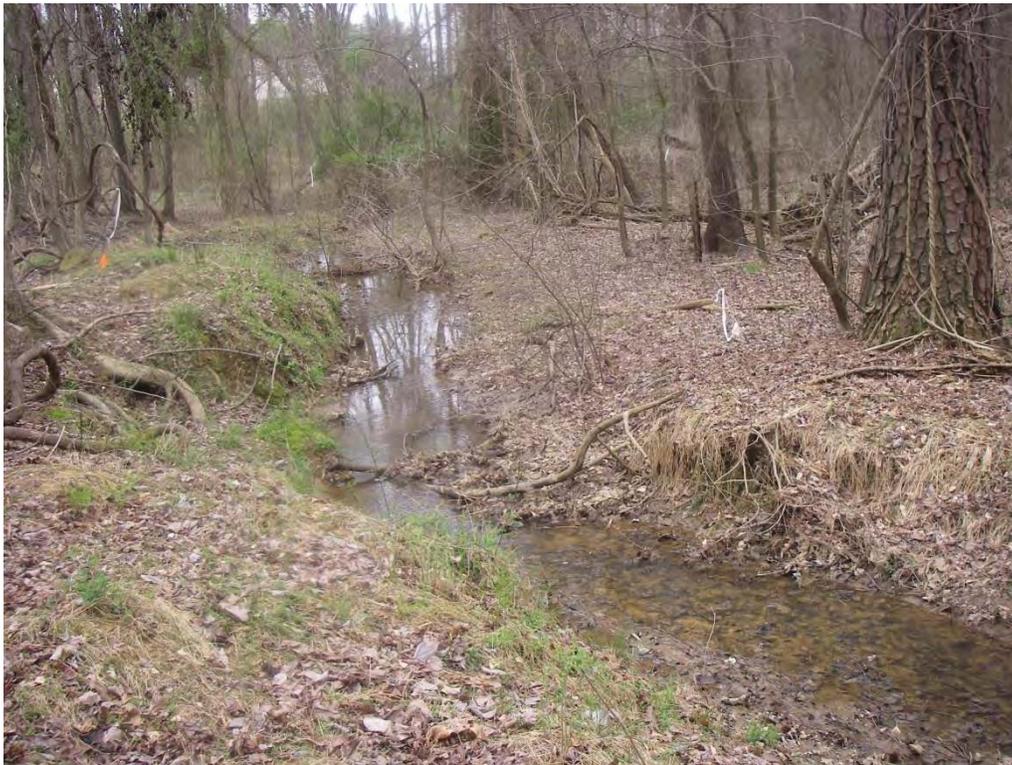
Tributary 8 upstream of Weaver Dairy Road

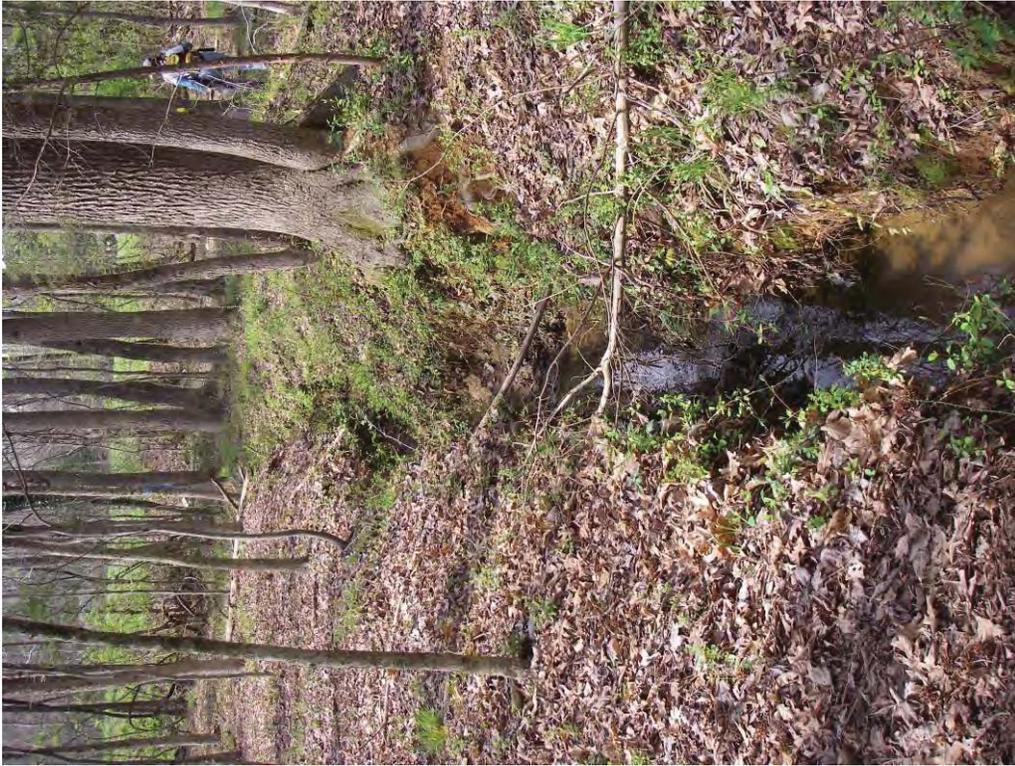
One branch of Tributary 8 drains about 32 acres of area along Homestead Road. Both headcutting and channel incision were observed along this sub-tributary. Immediately downstream of the culvert under Homestead Road, the channel is narrow and relatively deep, roughly two feet deep and two feet wide. A little further downstream, however, the stream branches into several multiple, poorly defined channels. The area at the confluence with Tributary 8, immediately upstream of a driveway crossing with an undersized culvert, exhibits extensive ponding and poor channel definition.

Downstream of Homestead Road on Trib 8A

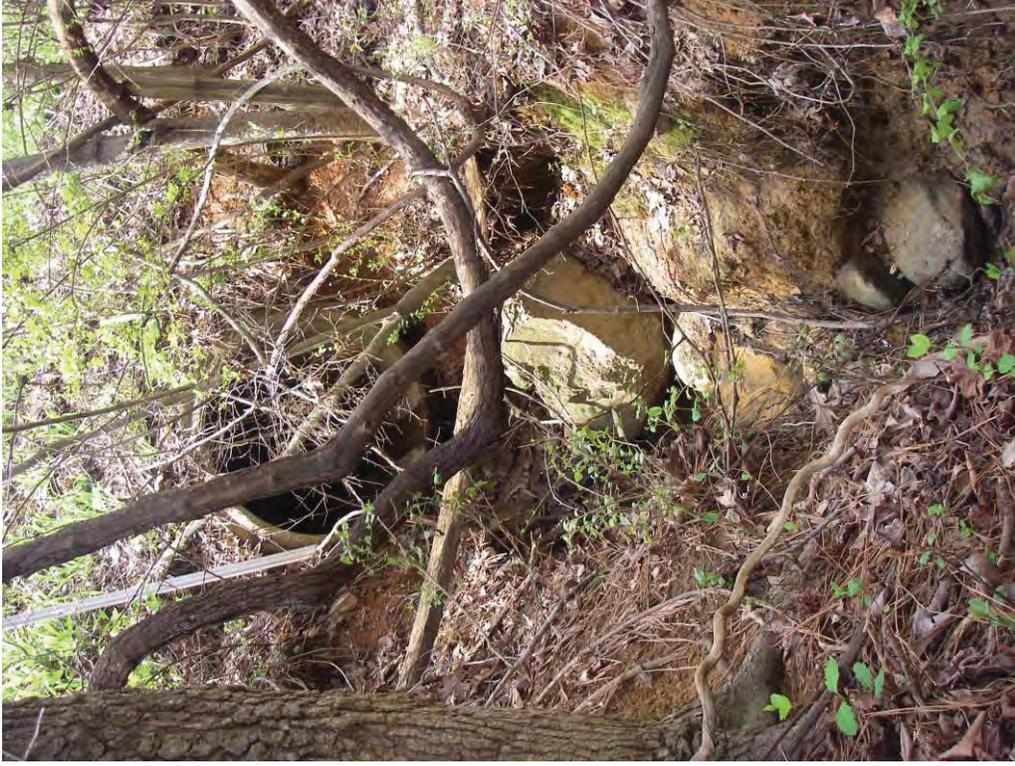
The Homestead Road culvert outlet is perched well above the stream bed and is clearly part an older section of pipe than what is in place on the upstream end, where there is a flared end section at the inlet. Apparently the previously existing pipe was retained and extended upstream when a turn lane was added for a new driveway. There is rip-rap at the outlet, but no scour hole has formed. The culvert outlet may have been somewhat perched when it was installed, but the condition has been aggravated by the channel incision. Photos of the culvert and the incised downstream reach are shown in Exhibit D-10.

Downstream end of Homestead Road Culvert

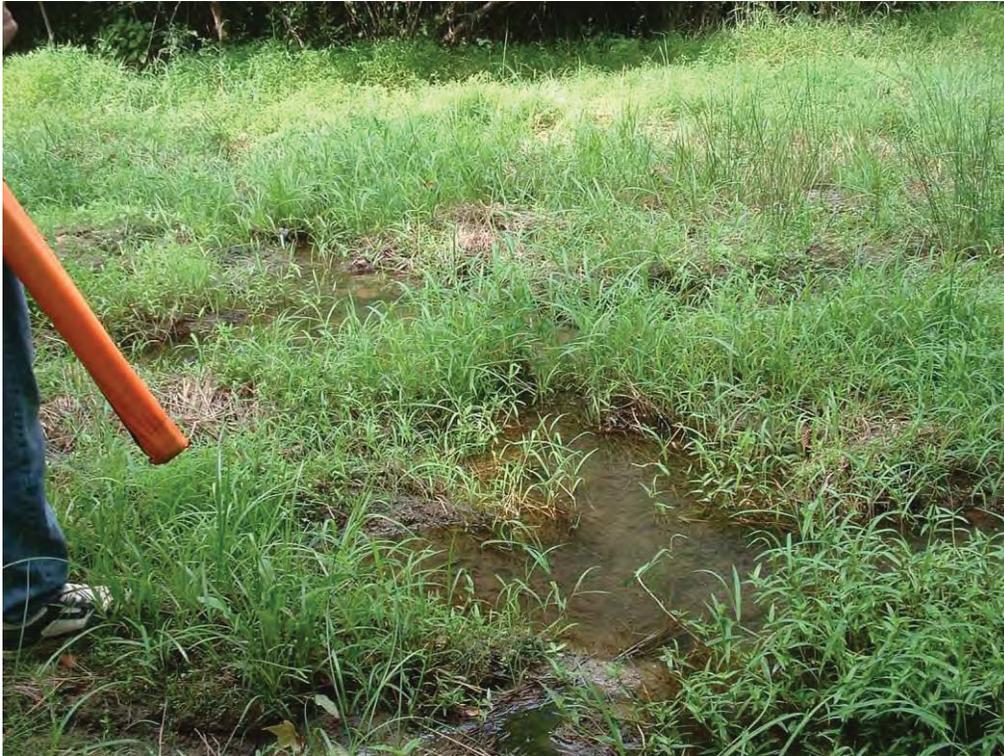
Tributary 9 drains an area of about 33 acres, beginning as a storm drain collection system on MLK Boulevard and running through the Parkside neighborhood, discharging into an unstable area of Reach C downstream of an OWASA crossing. The reach is mostly open channel along property lines or in backyards of single family residences, but includes a 500 foot reach of culvert in the area of Lonebrook Drive. The stream crosses an OWASA easement just upstream of where it discharges into Booker Creek. The stream is completely “mushed out” through the OWASA easement and there is no defined channel. Photos of the stream through the easement and in the wooded area just upstream are shown in Exhibit D-11.

OWASA crossing on Tributary 9

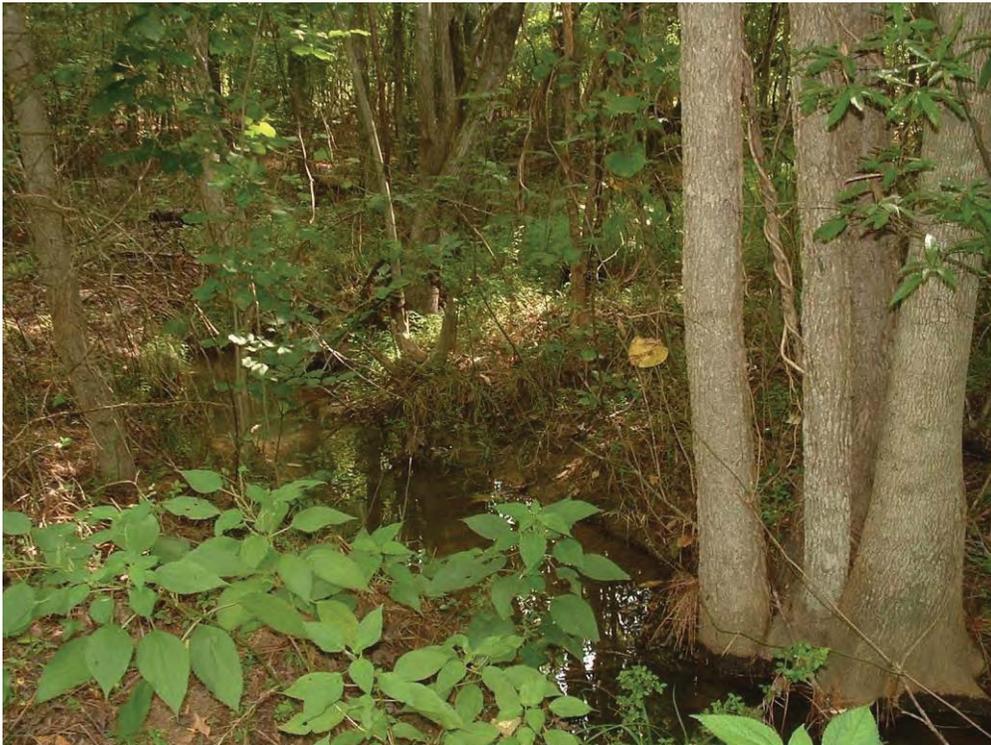
Looking upstream from OWASA crossing

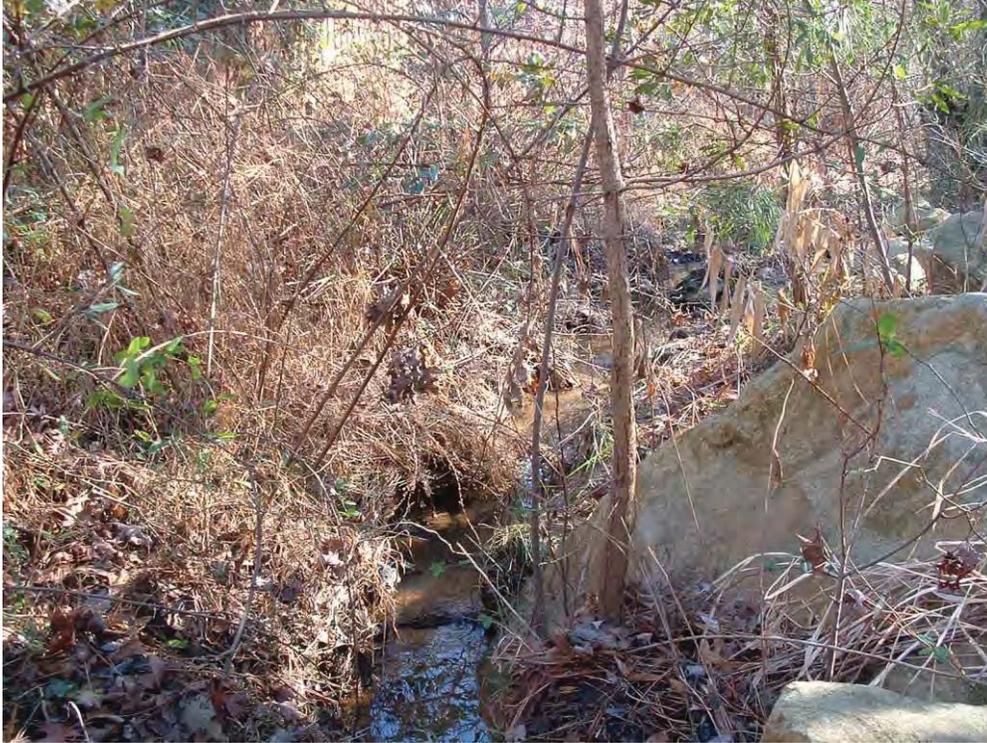
At the upper end of the catchment area for Tributary 10 are wooded areas on undeveloped properties west of Weaver Dairy Road. Two branches of the tributary flow in culverts under Weaver Dairy Road and Worsham Drive, converging in Town-owned RCD at a point about 400 feet east of Worsham Drive. Photos of Tributary 10 are shown in Exhibit D-12. The downstream reach of Tributary 10 is somewhat incised, but the upper reaches are still well-connected to the surrounding floodplain and have very minimal erosion.

one of the upstream reaches

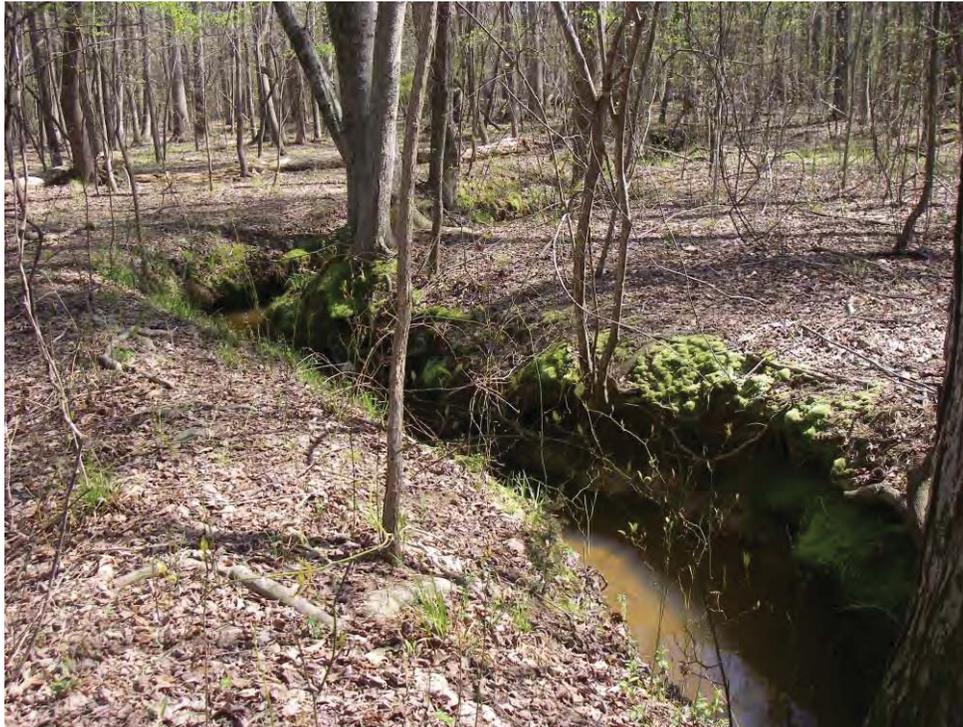
downstream of Parkside Drive

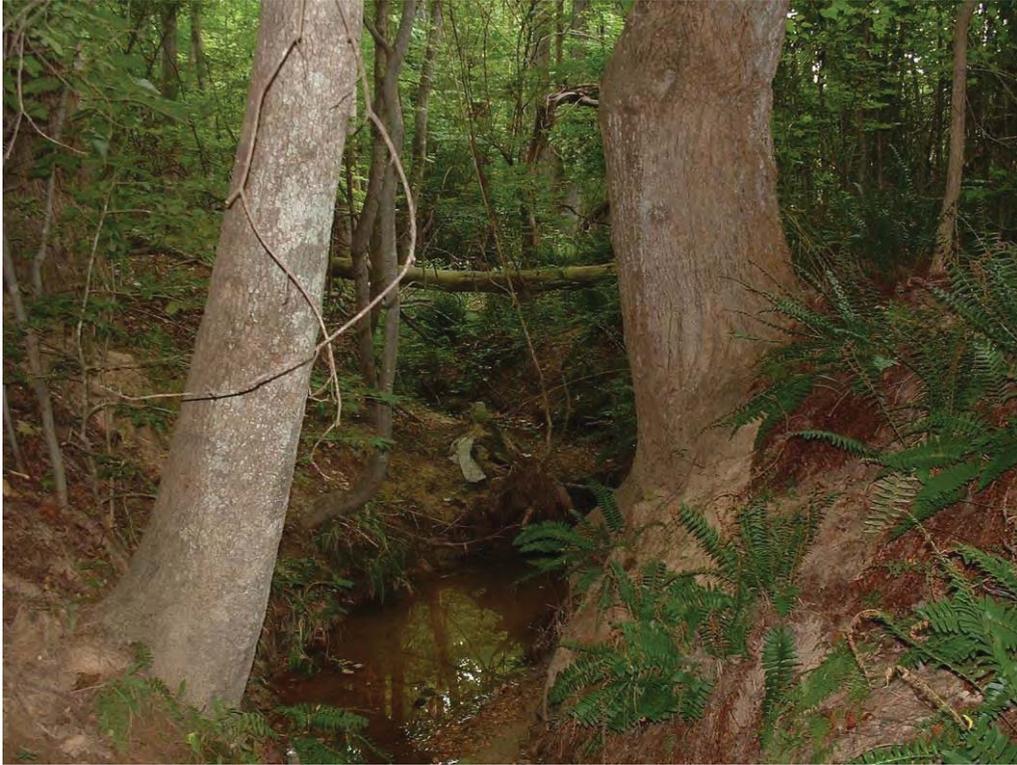
Tributary 11 drains roughly 48 acres in the northeast corner of the subwatershed, including areas north of Weaver Dairy Road and a small area east of MLK Boulevard. Upstream of the culvert under Lonebrook Drive, the stream is steeply sloped and there is some evidence of headcutting beginning to move upstream. The headcutting may have been triggered by hydrologic changes due to development or could have been caused by construction of the culvert at a lower invert elevation than the original stream bed. Photos of this area are shown in Exhibit D-13.

downstream of Lonebrook Drive
