Appendix D

***Pilot Basin Study Interim Report
Booker Headwaters Subwatershed***

Pilot Basin Study Report – Booker Headwaters Subwatershed

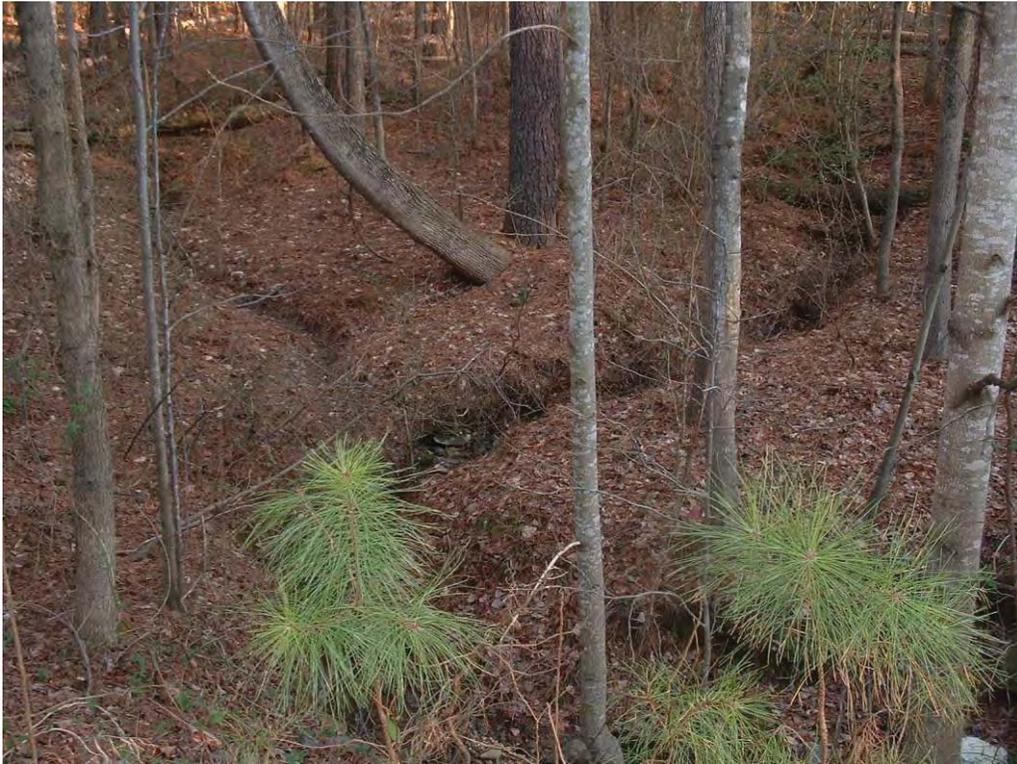
Tributary 11 drains roughly 48 acres in the northeast corner of the subwatershed, including areas north of Weaver Dairy Road and a small area east of MLK Boulevard. Upstream of the culvert under Lonebrook Drive, the stream is steeply sloped and there is some evidence of headcutting beginning to move upstream. The headcutting may have been triggered by hydrologic changes due to development or could have been caused by construction of the culvert at a lower invert elevation than the original stream bed. Photos of this area are shown in Exhibit D-13.

upstream of Lonebrook Drive

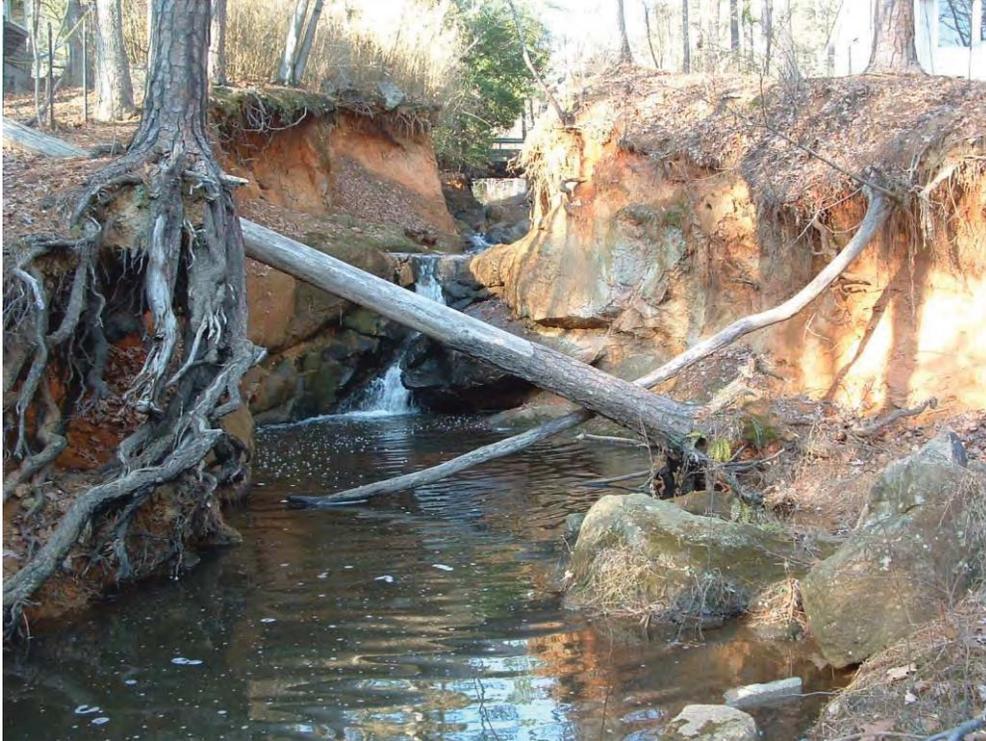
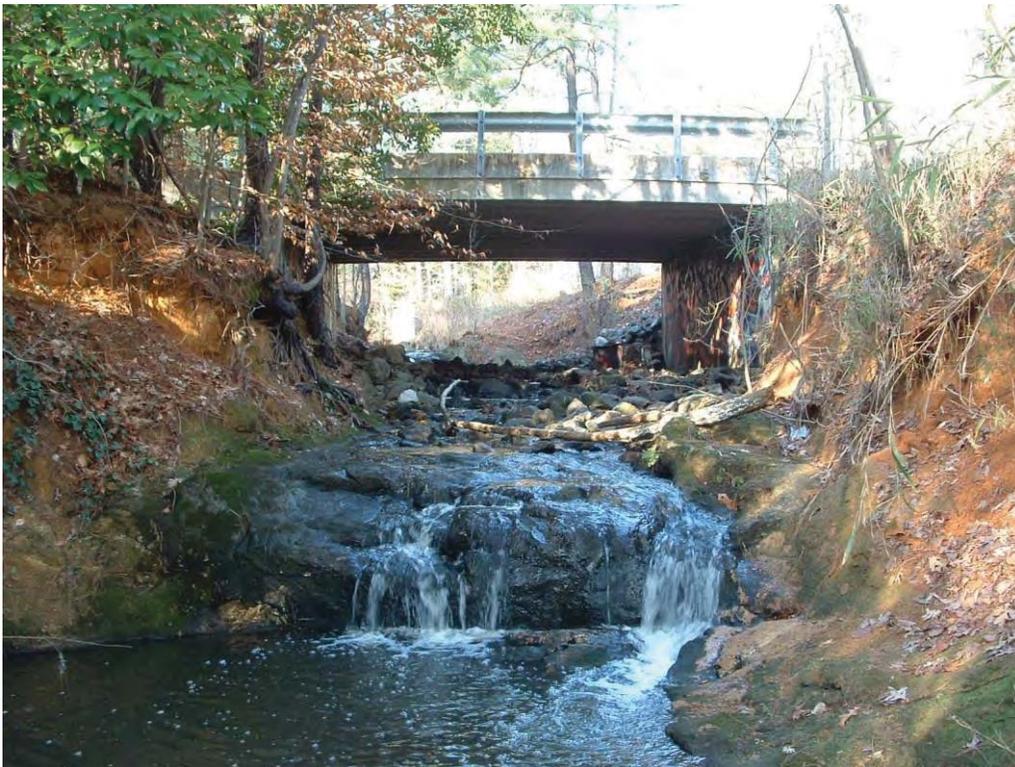
Exhibit D-14. Photos of Reach Downstream of Lake Ellen

This re-routing of flow has resulted in very severe erosion downstream of the lake. The size of a natural stream is developed over time in response to the overall regime of flows experienced. The dynamics of the adjustment are driven by an energy balance of flows, sediment loads and channel slope. Thus, the increased flows have resulted in channel incision, along with ongoing

stream bank erosion. The channel has cut down to bedrock along most of the reach in a series of natural drops. However, it remains a very steeply sloped channel such that it is unlikely to retain sediment and rebuild a floodplain within the enlarged channel, as would a more typical urban stream. Velocities will remain high, even with the widened channel, and bank erosion is likely to continue. Banks are very steep and as high as 20 feet in some areas. Although the stream is not a candidate for restoration, bank stabilization could be considered if the two property owners involved are amenable to such improvements, including the excavation that would be required to adequately slope back the banks and provide energy dissipation drops and pools along the reach. Some photos of this reach are shown in Exhibit D-13.

The outlet structure for Lake Ellen is a simple concrete weir, approximately 40 feet wide according to the information in the FEMA model. Immediately downstream of the weir, the channel is not eroded and the bed is not incised. The erosion begins at a point between the outlet and the bridge downstream and is extensive in the area of the bridge, even though the bridge structure itself does not appear to be compromised. The outlet structure could be replaced with one that facilitates some degree of extended detention and also incorporates energy dissipation.
