# Fordham Boulevard Trail Assessment Report

The Fordham Boulevard Trail is in Chapel Hill, North Carolina, along Fordham Boulevard (US 15-501) from Cleland Drive to Ridgefield Road. The trail is approximately 1,700 linear feet and includes one timber boardwalk that crosses Bolin Creek near Estes Drive.

Kimley-Horn performed a site visit to the Fordham Boulevard Trail on January 31, 2018 to document the current condition of the trail and existing boardwalk. Throughout the course of the visit, the weather was clear and sunny. Our objective was to determine design deficiencies that do not meet NC Bicycle Program and AASHTO standards, summarize our findings, and recommend design solutions to bring the trail up to NC Bicycle Program and AASHTO standards. Our field evaluation was performed using visual, non-destructive observations of the trail and boardwalk. Our scope did not include materials testing, hydraulic calculations, or structural calculations. A general description, key findings, and photographs are included in this report to provide the Town with baseline information.

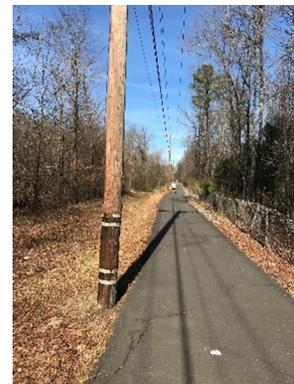
Figure 1: Trail looking north from Cleland Drive

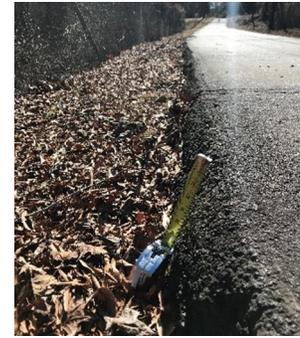
Figure 2: Existing Shoulder Edges

- To elevate the sharp drop-offs along the trail edges we recommend building 2-foot earth shoulders along both sides of the 8-foot asphalt trail.
- Relocate the two poles closest to Cleland Drive at least 2 feet from edge of trail (one pole is on trail edge and the other is 1.5 feet from trail edge). ADA requires 2-foot clearance from obstacles. At a minimum, we recommend that the Town add warning signs to warn users of obstructions.

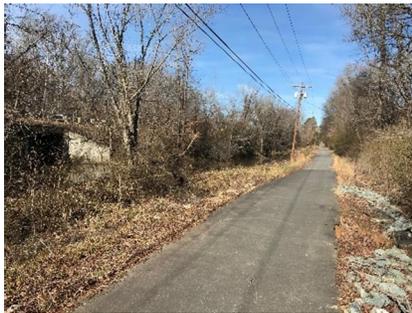
Figure 3: Existing Scour

- To prevent the periodic flooding of the trail, relocate or boardwalk the entire section of trail that is within the flood prone areas. This improvement would be costly for the Town and require additional funding. A more cost-effective approach would be to reinforce the entire flood areas with a mixture of Class 'I' and 'B' rip rap along the eastern side and reconstruct the trail in this flood prone area to reinforced concrete. This improvement would help reduce trail maintenance in this area due to the existing scour on the eastern side of the trail.

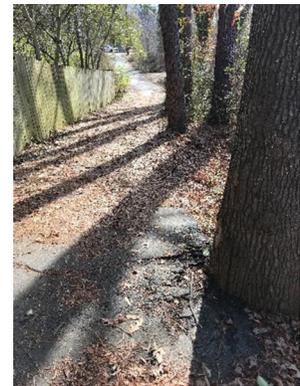
Figure 4: Tree Encroachments

- Multiple cracks in asphalt surface from tree roots and subgrade failure. Tree roots can be pruned at 2 feet from edge of trail and roots removed. Trees and stumps within the 2-foot clear zone (close to Ridgefield Drive) need to be removed. Damaged trail should be patched back in both situations.
- The asphalt trail has settled at both ends of the boardwalk causing a tripping hazard. We recommend patching the asphalt or replacing with reinforced concrete at each end of the boardwalk to create a smooth transition from asphalt trail to timber boardwalk.
- At a minimum, we recommend widening the trail to a 10-foot width at the bollard locations so that there is enough clear zone for cyclists on both sides of the bollard.

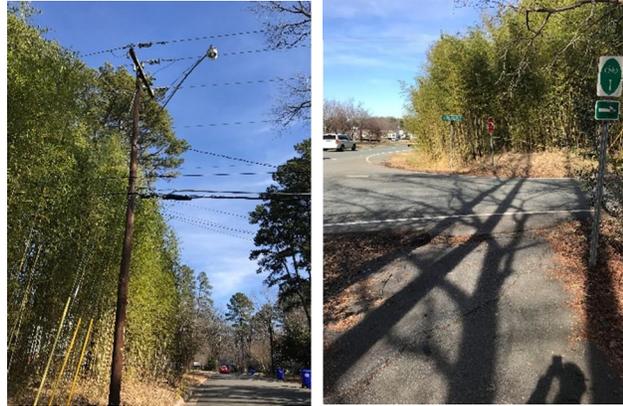
Figure 5: Crossing and Lighting at Ridgefield Drive

- Add trailhead bollards and signage (“Stop” and “No Motor Vehicles”) to all areas where the trail connects with adjacent roads (Cleland Drive, Estes Drive, and Ridgefield Road).
- Add truncated domes to curb ramps per ADA requirements at all roadway crossings (Cleland Drive, Estes Drive, and Ridgefield Road).
- Sweep/blow off the section regularly to remove any debris from flooding.
- Ensure existing lighting is operating properly, is bright enough, and illuminates the existing crosswalk areas at Cleland Drive, Estes Drive, and Ridgefield Road trail crossings. This will improve the safety of those crossings. Town should review crosswalk high-visibility markings and appropriate warning signage for vehicles to be aware of trail crossings.

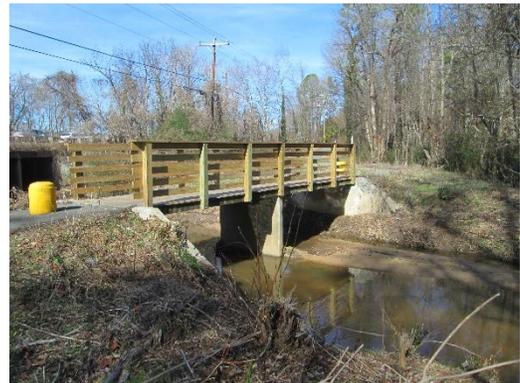
Figure 6: Boardwalk

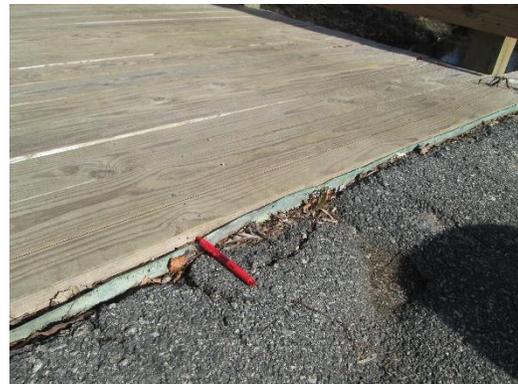
The asphalt trail has settled at the both ends of the boardwalk causing a tripping hazard. It is recommended that the asphalt at each end of the boardwalk be patched or replaced with reinforced concrete to create a smooth transition from asphalt trail to timber boardwalk.

Figure 7: Tripping Hazard

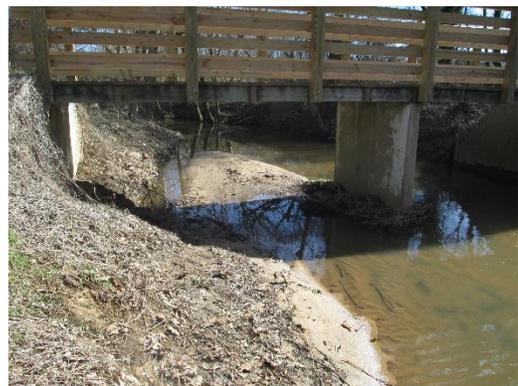
Substructure appears to be in good condition. However, no rip rap was observed protecting the 3 substructure elements from scour. It is recommended that the Town monitor the progress of any scour and add rip rap to protect substructure as necessary.

Figure 8: Substructure

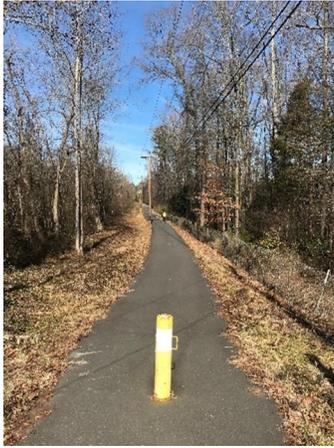
Photo 1  
Cleland Drive Looking North

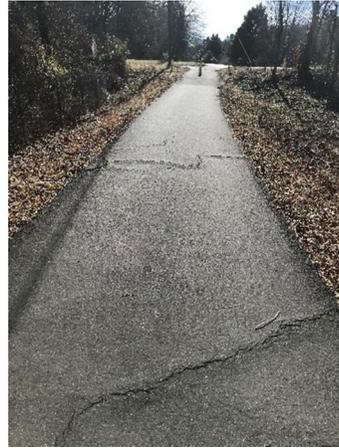
Photo 2  
Asphalt Cracks

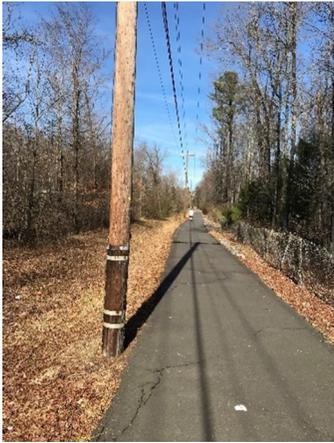
Photo 3  
Utility Pole on Path Edge

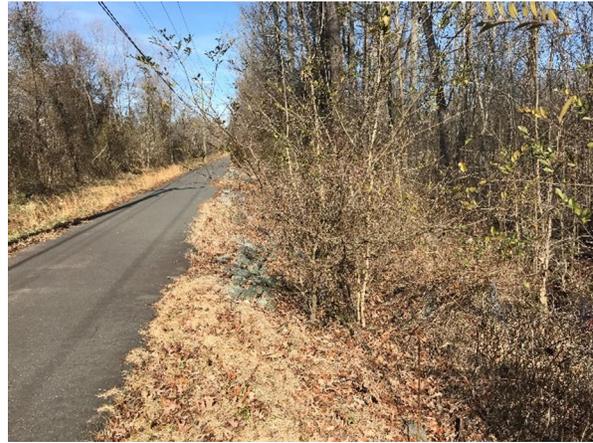
Photo 4  
Damaged Control of Access Fence with Debris

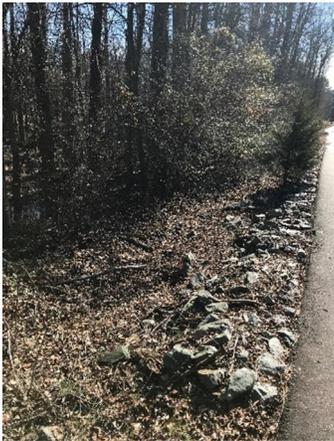
Photo 5  
Scoured Path Edge

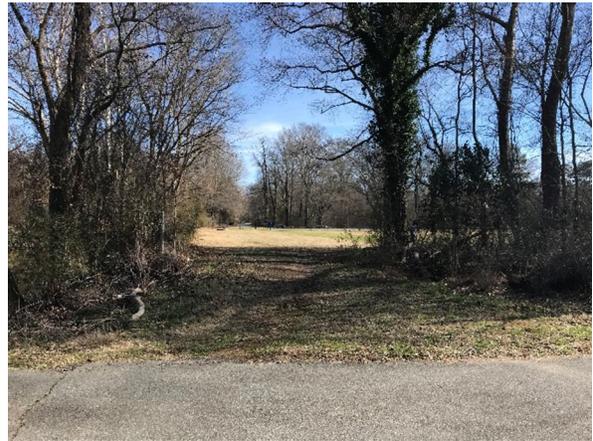
Photo 6  
Unofficial Access to Multi-Use Path

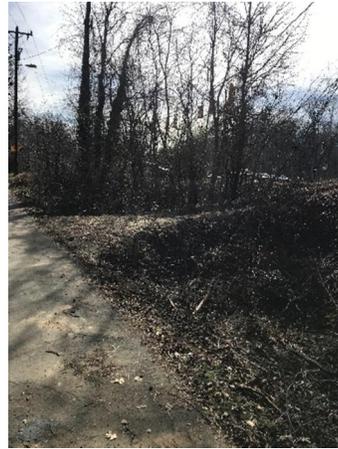
Photo 8  
Soil Spur to Fordham Blvd.

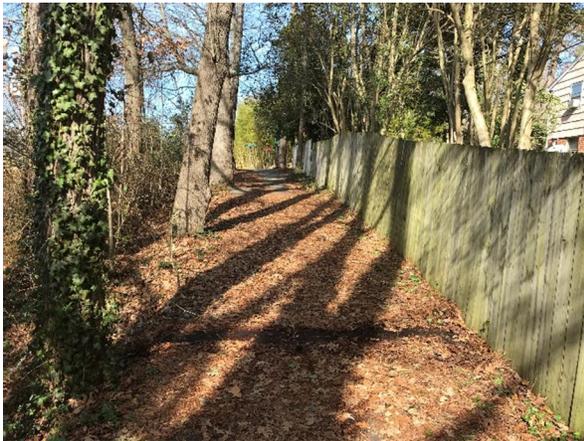
Photo 9  
Fence 6" from Path Edge

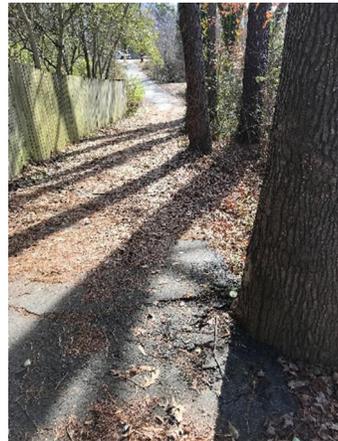
Photo 10  
Trees in Path

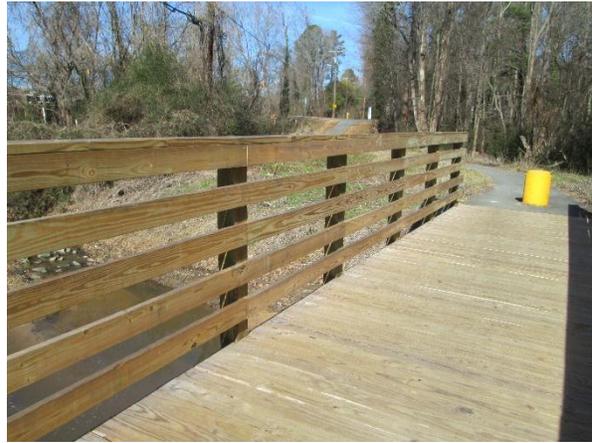
Photo 16  
Timber Railing

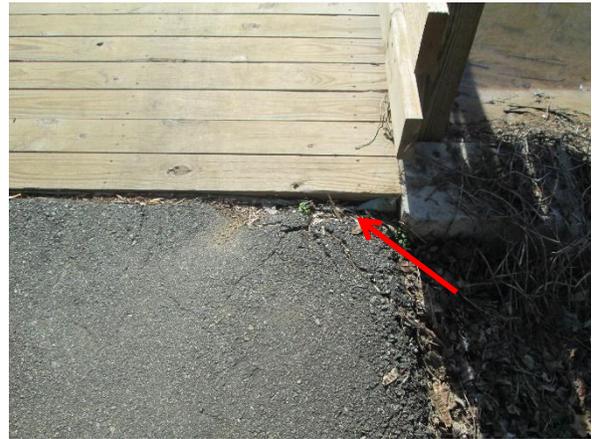
Photo 18  
Tripping Hazard North End

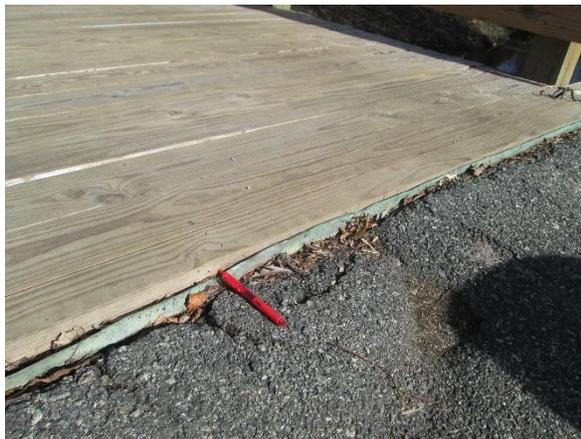
Photo 23  
Tripping Hazard South End
