March 27, 2017

Re: Preliminary Engineering Evaluation
Town of Chapel Hill – American Legion - Pond

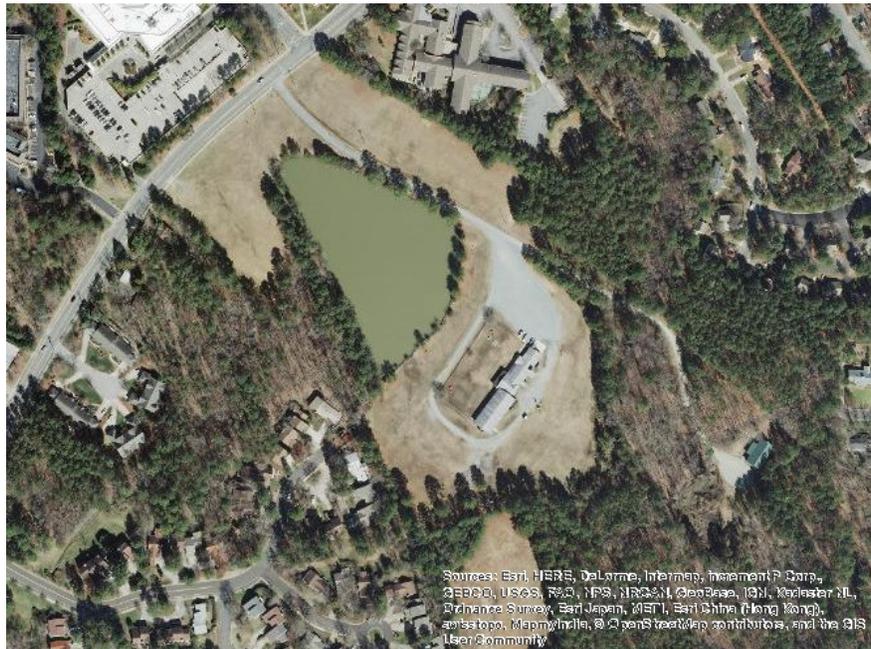
Figure 1. The American Legion Property in Chapel Hill.

The American Legion property (**Figure 1**) site contains an existing earthen dam, one stream along the northeastern boundary of the site, another stream leading out of the dam from its discharge point, and protected buffer areas around the dam and the pond it encloses, as well as the northeastern stream (**Figure 2**).

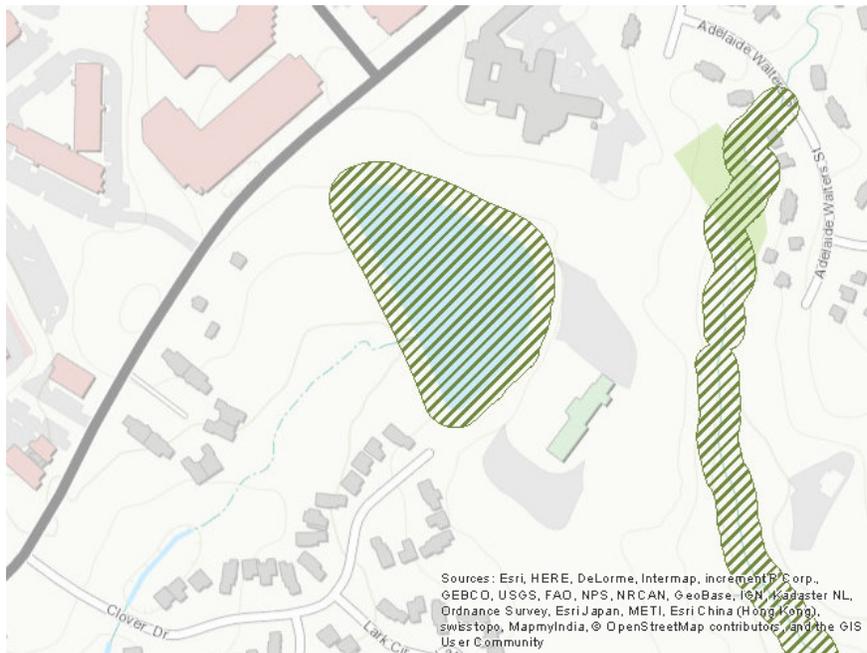
Figure 3. Buffers on the American Legion property.

The stream along the northeastern boundary of the site is perennial at its eastern-most point, and transitions into an intermittent stream at the northern edge of the property. The protective buffer around the perennial portion of this stream is 150-foot wide (50-feet for stream side, 50-feet for managed use, and 50-feet for the upland region). The buffer around the intermittent portion is 50-foot wide, for stream side only. The Town has determined that a 50-foot buffer applies to the pond (**Figure 3**).

The stream leading from the outlet of the dam is entirely intermittent, based on discharges from the dam. GIS data does not identify a protected buffer for this stream (**Figure 3**).
