SITE 32

Restoration of Stream channel off Cleland Rd

Geomorphic Analysis and Identification of Potential Sites for Stormwater BMPs
Orange County, North Carolina

*Bolin Creek Watershed
Geomorphologic Analysis and Potential Site Identification for Stormwater BMPs and Retrofits*

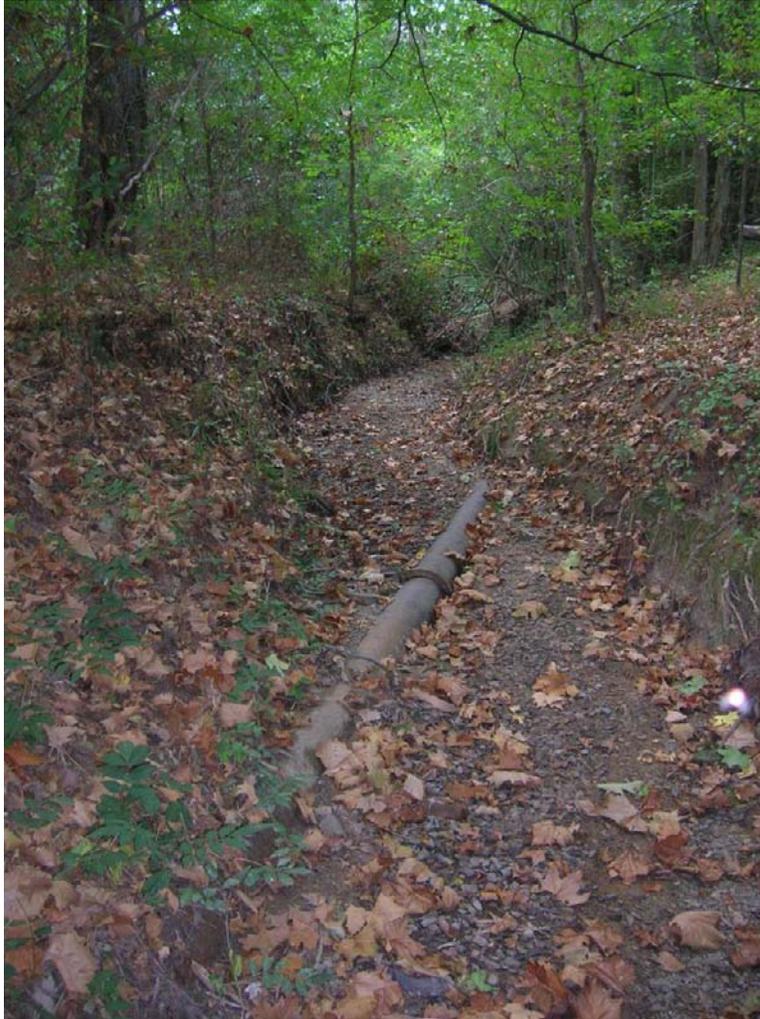
Site 32 consists of a channelized, incised stream channel in the lower portion of the Bolin Creek Watershed. The stream appears to have been channelized and straightened at some point in the past, possibly during construction of the surrounding residential area and soccer fields. The resulting channel is incised and devoid of any natural stream habitat. The relic floodplain of the stream is filled with piles of spoil material, and heavily infested with exotic invasive species such as wisteria, multiflora rose, and privet. The contributing drainage area of the stream is comprised of medium to heavily developed residential areas, and a portion of US 15-501. Most of the stormwater in this drainage area is piped and discharges from an outlet at the southernmost edge of the Site 32. Bank erosion and BEHI ratings of “high” were observed along the entire reach.

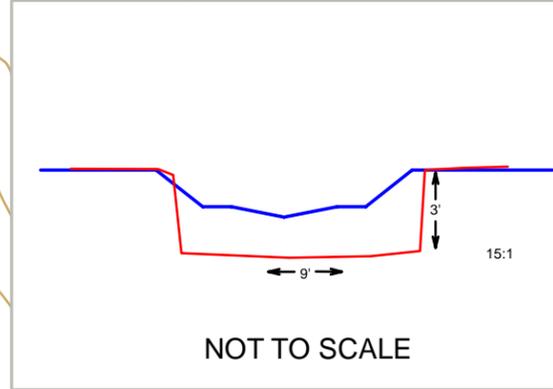
CONCEPTUAL CROSS SECTION

The stream channel that is the focus of treatment at this site is an ideal site for Priority I Restoration. Priority I restoration involves reconnecting the stream with the relic floodplain by raising the elevation of the bed, thereby restoring floodplain hydrology, reducing near bank stress and thus limiting the bank erosion problem. This site possesses ideal circumstances for this practice: a wide, intact relic floodplain and little need to meet elevations, other than the outlet pipe at the upstream end and the roadway culvert at the downstream end. Most of all, almost the entire floodplain is on state owned land, providing ample opportunity for changes in the planform and sinuosity of the stream. Besides the sediment reduction, stream restoration will provide the restoration of critical habitat for numerous aquatic species, as well as the hydrology needed to support riparian wetlands.
