SITE 21

Restoration of Stormwater Outfall and Gulley off of Hillsborough St.

Geomorphic Analysis and Identification of Potential Sites for Stormwater BMPs
Orange County, North Carolina

*Bolin Creek Watershed
Geomorphic Analysis and Potential Site Identification for Stormwater BMPs and Retrofits*

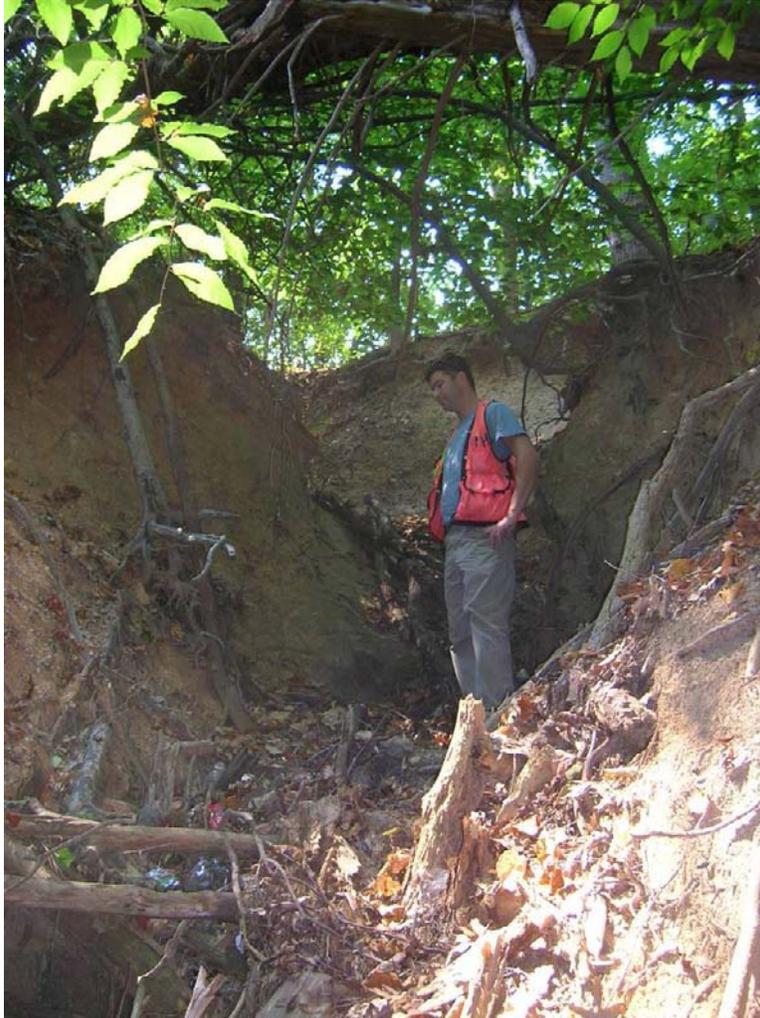
Site 21 consists of a deep, actively eroding gulley on a hillside below a stormwater pipe outlet from Hillsborough Street.

Stormwater runoff from Hillsborough Street and surrounding houses collects into a curb and gutter system along the street, and then is discharged at several outlets as the street runs downhill from the downtown area of Chapel Hill towards Bolin Creek. One of these outlets discharges at the top of a steep hill, with a drop of approximately 30 feet over a distance of approximately 100 feet. At the base of the hill is a tributary to Bolin Creek. There is no energy dissipation structure at this outlet, and thus the stormwater has concentrated as it flows downhill towards the stream, forming a massive gulley that is approximately 8 feet deep. The sides of this gulley are actively eroding, and likely contributing a large amount of sediment to the watershed each year.

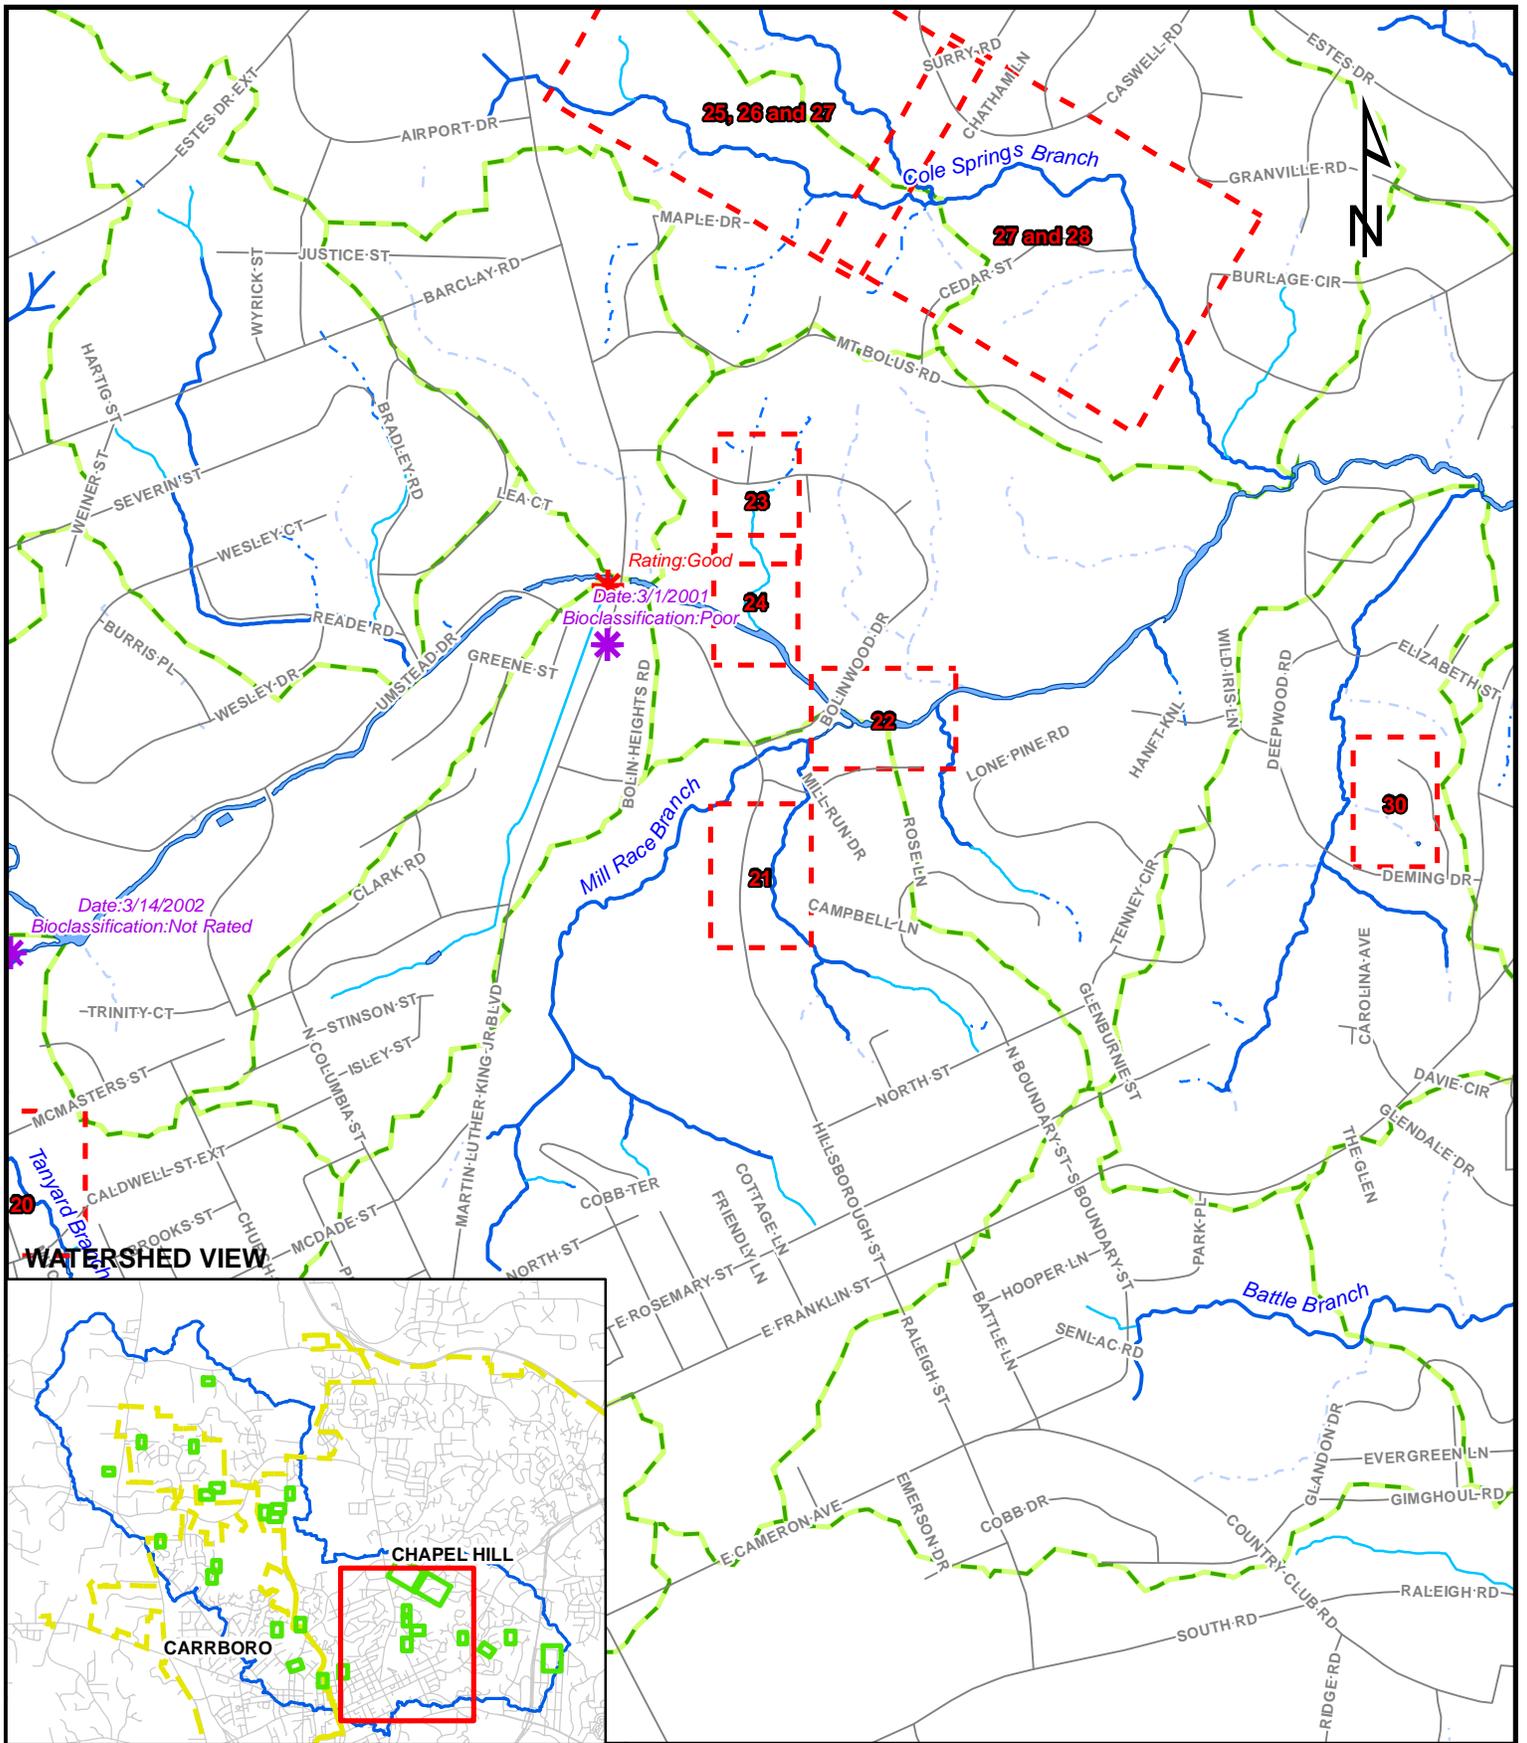
SITE 21 VICINITY MAP

Site 21 is located off of Hillsborough Street, approximately 0.3 miles north of the intersection of Hillsborough St. and Rosemary St.

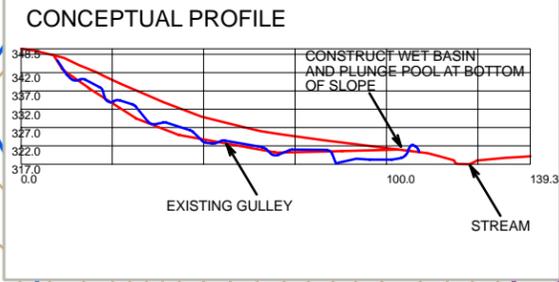
CONCEPTUAL PLAN VIEW
BOLIN CREEK WATERSHED
Geomorphic Analysis and Potential Site
Identification For
Stormwater Structures and Retrofits

ALTERNATIVE 2:
CONSTRUCT CONCRETE FLUME WITH
FRICTION BLOCKS

USE LARGE BOULDERS TO
DEFINE CHANNEL

EXISTING
OUTLET

WET POND

LEVEL SPREADER

ALTERNATIVE 1: RECONSTRUCT EXISTING
GULLEY INTO "A" CHANNEL

Alternative 1: Construct an “A” channel in the existing gully, using large boulders and stone to define the channel. Construct a wet detention basin at the bottom of the hillslope, containing a permanent pool where the channel meets the basin, to provide energy dissipation. The depth of the basin should be higher in elevation than the bed of the stream, so that groundwater will discharge from the basin and recharge the stream. The bottom of the basin should consist of a porous soil media to allow infiltration through the soil. The overflow structure will be two level spreaders situated parallel to the stream.

Alternative 2: Construct a concrete-lined channel with friction blocks, rather than an “A” channel, and the wet detention basin and level spreaders described above.

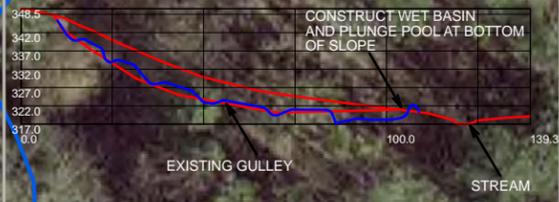
AERIAL PHOTO VIEW

ALTERNATIVE 2:
CONSTRUCT CONCRETE FLUME WITH
FRICTION BLOCKS

USE LARGE BOULDERS TO
DEFINE CHANNEL

EXISTING
OUTLET

ALTERNATIVE 1: RECONSTRUCT EXISTING
GULLEY INTO "A" CHANNEL

LEVEL SPREADER

WET POND
