SITE 19

Stream Restoration/Bank Stabilization in Park

Geomorphic Analysis and Identification of Potential Sites for Stormwater BMPs
Orange County, North Carolina

Bolin Creek Watershed
Geomorphic Analysis and Potential Site Identification for Stormwater BMPs and Retrofits

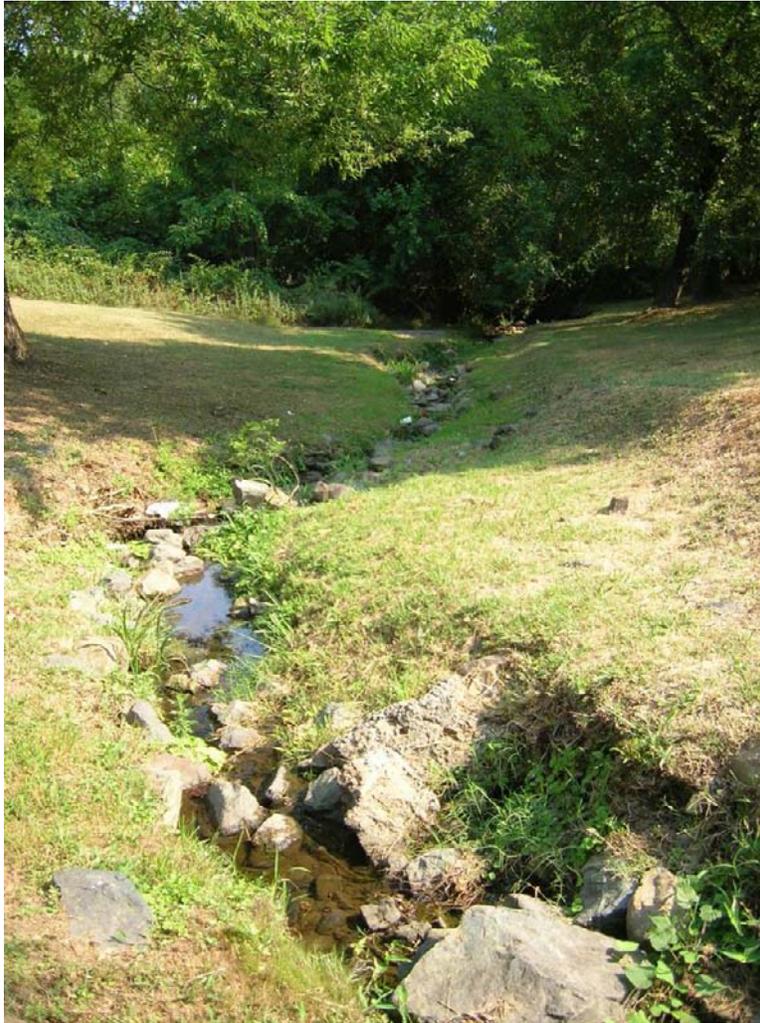
Site 19 consists approximate 165 feet of an incised reach of Tanyard Branch, with actively eroding, vertical banks and lack of a riparian buffer. Upstream of the site, the stream is completely piped, and emerges from a culvert after passing under Broad Street, where it then flows through a town-owned park. The eroding streambanks are likely the result of what was observed to be repeated mowing up to the stream (mechanical stresses on the channel) and a lack of riparian buffer to resist the high shear stress coming from the concentrated flow discharge of the upstream pipe network. The eroding stream banks are causing export of sediment and associated nutrients. A preliminary investigation of streambank erosion potential using the BANCS model indicates that approximately 29 tons of sediment is being exported from the site each year. Concomitant nutrient export associated with the sediment has also been calculated and is listed in **Table 19.1**.

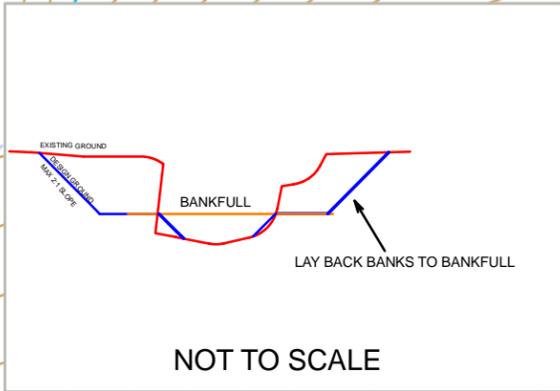
CONCEPTUAL CROSS SECTION

ALTERNATIVE 2:
LAY BACK BANKS WITH BANKFULL BENCH
AND VEGETATE WITH LOW GROWING GRASS

ALTERNATIVE 1:
LAY BRUSH MATTING ON BOTH BANKS
AND REVEGETATE WITH LOW-GROWING GRASS

ALTERNATIVE 3:
LAY BACK BANKS AND MODIFY
PROFILE AND GEOMETRY

ALTERNATIVE 2 AND 3:
ADD DISSIPATION POOL AT HEAD OF PROJECT

- a bankfull bench that gives the stream a floodplain to access, thus significantly reducing near bank stress during above-bankfull events
- reduced slopes on the bank, at a maximum of 2:1, thus reducing potential for bank erosion
- vegetated banks with woody plants that will provide stabilization through rooting mass

Alternative 1: Rather than laying back banks and incurring the expense of earthwork, brush matting (see Details) could be laid on all banks, providing a certain degree of resistance of erosive flows and reducing bank erosion. The riparian buffer area could then be re-vegetated with low-growing plants, as mentioned above.

Alternative 2: To reduce bank erosion rates to the greatest extent, lay back the stream banks at a maximum 2:1 slope and construct a bankfull bench. Then re-vegetate the riparian buffer with low-growing plants.

Alternative 3: In addition to the treatment of Alternative 2, modify the profile of the stream, constructing pools at each meander bend of the existing channel. This will lead to further dissipation of energy, while improving in-stream habitat.

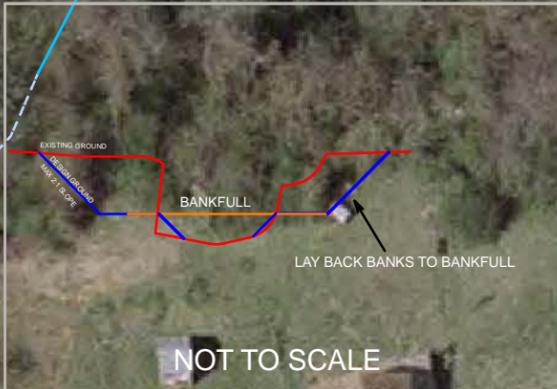
CONCEPTUAL CROSS SECTION

ALTERNATIVE 2:
LAY BACK BANKS WITH BANKFULL BENCH
AND VEGETATE WITH LOW GROWING GRASS

ALTERNATIVE 1:
LAY BRUSH MATTING ON BOTH BANKS
AND REVEGETATE WITH LOW-GROWING GRASS

ALTERNATIVE 3:
LAY BACK BANKS AND MODIFY
PROFILE AND GEOMETRY

ALTERNATIVE 2 AND 3:
ADD DISSIPATION POOL AT HEAD OF PROJECT
