SITE 18

Restoration of Erosive Gulley Beneath Railroad Trestle, and Treatment of Pollutants From Subdivision

Geomorphic Analysis and Identification of Potential Sites for Stormwater BMPs
Orange County, North Carolina

*Bolin Creek Watershed
Geomorphic Analysis and Potential Site Identification for Stormwater BMPs and Retrofits*

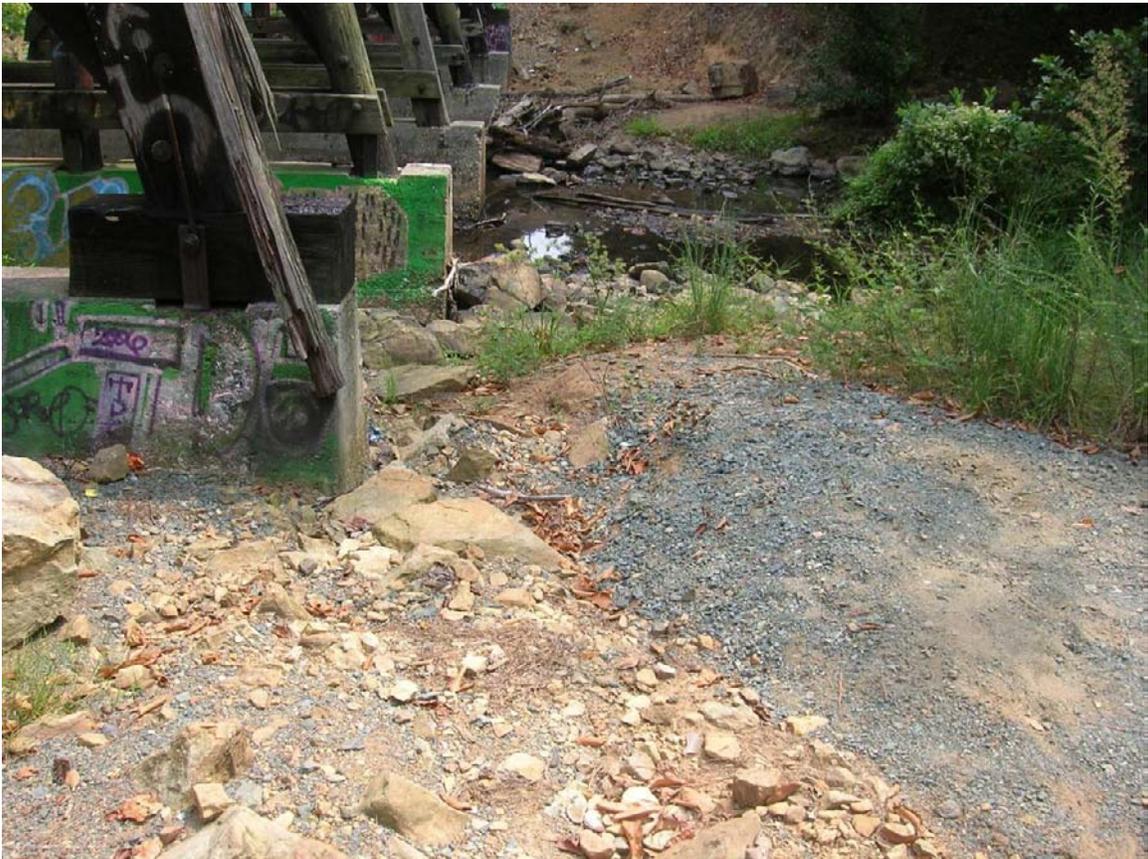
Site 18 consists of two actively eroding headcuts on an exposed hillslope adjacent to a railroad trestle. Upslope of the gully is a subdivision and what appears to be an ephemeral stream discharging from the storm system of the neighborhood, which consists of a curb and gutter drainage system. The runoff that accumulates on the relatively high percentage of impervious surface concentrates in the gully just before reaching Bolin Creek, causing severe scour and mass wasting, and contributing sediment to the watershed, as well as any pollutants that may be contained in the runoff from the subdivision. There is also an indication that impacts from recreational use of this site could be adding to the problem of the erosive banks by causing bank failure in between rainfall events.

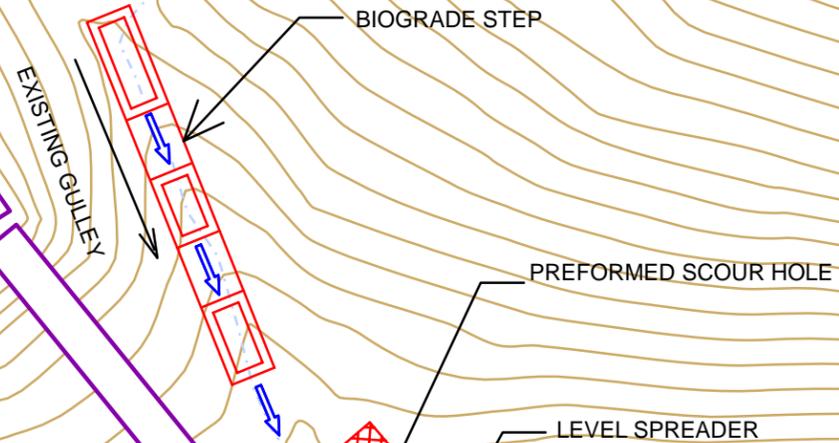
CONCEPTUAL PLAN VIEW
BOLIN CREEK WATERSHED
Geomorphic Analysis and Potential Site
Identification For
Stormwater Structures and Retrofits

Site 18 poses a unique situation for stormwater treatment; a steep slope and limited space between the area of the headcuts, the footers of the railroad trestle and Bolin Creek. A solution for treatment at this site is to construct a “bio-grade step”, which is a series of small bio-retention cells filled with a filter media, such as a mixture of sand, fines and organic mater (see Appendix A-Details). Ideally, this media will have a filtration rate of 1.0 to 2.0 inches per hour, to optimize pollution removal (Schueler, et. al., 2007). Each cell is connected to the other by the use of a drainage or seepage layer, thus allowing stormwater to filter through each cell without the expense of an underdrain. An underdrain is also an option if it is preferred. Each cell would have a given amount of volume to fill while infiltrating before cresting the berm and overflowing into the next cell downstream. Below the bio-grade step, a preformed scour hole (see Appendix A-Details), should be built to dissipate any overflow before reaching Bolin Creek. There is not enough room to dissipate energy via a level spreader.

EXISTING RAILROAD TRESTLE

This treatment option will provide a linear, grade-control solution to reduce erosive velocities of the stream, while also treating stormwater runoff for pollutants. A substantial amount of storage volume, with respect to drainage area, can help to reduce

the total runoff that Bolin Creek receives. This may also augment baseflow to Bolin Creek by delaying the release of the stored runoff volume. It is important to note that this bio-grade step should drain completely over a period of 5-7 days in order to insure that there is available storage volume for runoff from the next rain event. Thus, the design of the weeps or drainage layers is an important factor for the continual success of this project.

The depth of each cell can vary depending on choice of planting materials. Trees, with a deeper rooting structure, will require deeper soils, while herbaceous plants and shrubs can have soil as shallow as 1.5 feet (Schuler et. al, 2007). Potential pollution removal rates using this method have been estimated and are shown in **Table 18.2**.

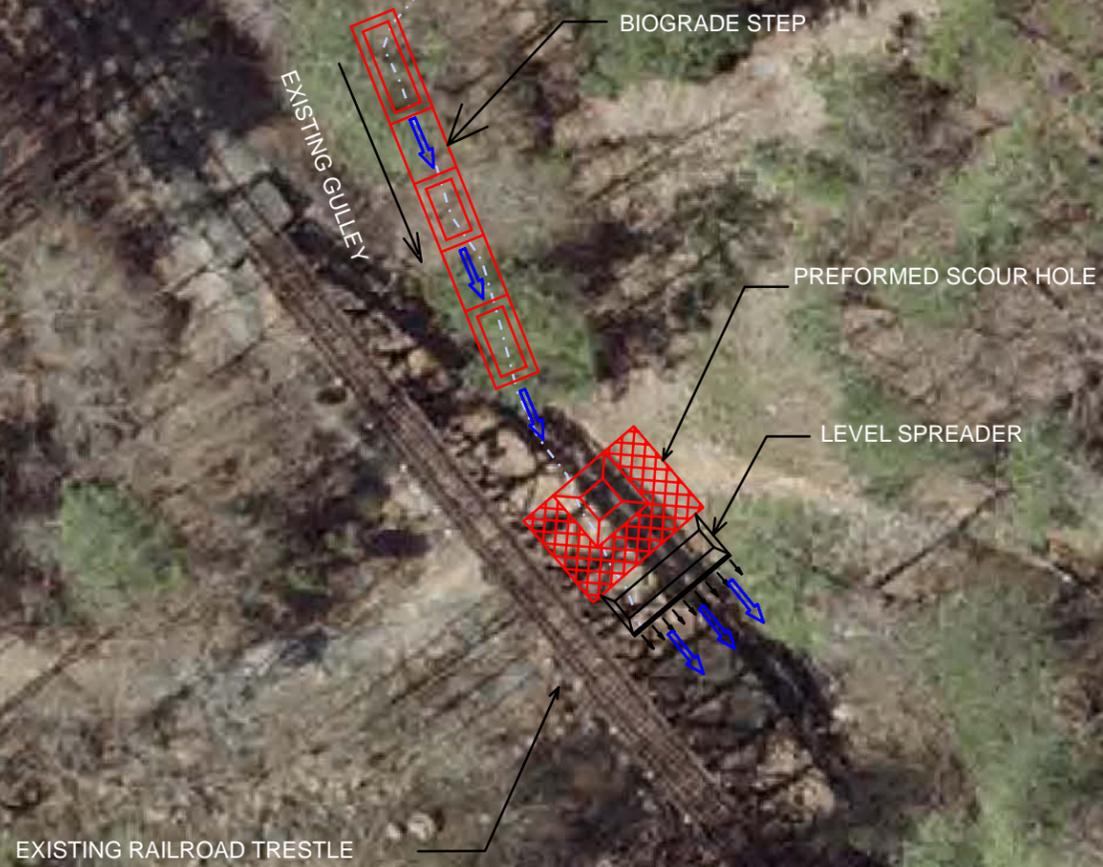
AERIAL PHOTO VIEW

Site 18 is located beneath a railroad trestle approximately 500 feet to the west of Estes Drive Extension. The railroad trestle crosses over Bolin Creek, and the site is located on the left bank, looking downstream. Access to the site can be obtained by traveling along an existing sewer easement and footpath that follows the stream.
