SITE 13

Geomorphic Analysis and Identification of Potential Sites for Stormwater BMPs
Orange County, North Carolina

*Bolin Creek Watershed
Geomorphic Analysis and Potential Site Identification for Stormwater BMPs and Retrofits*

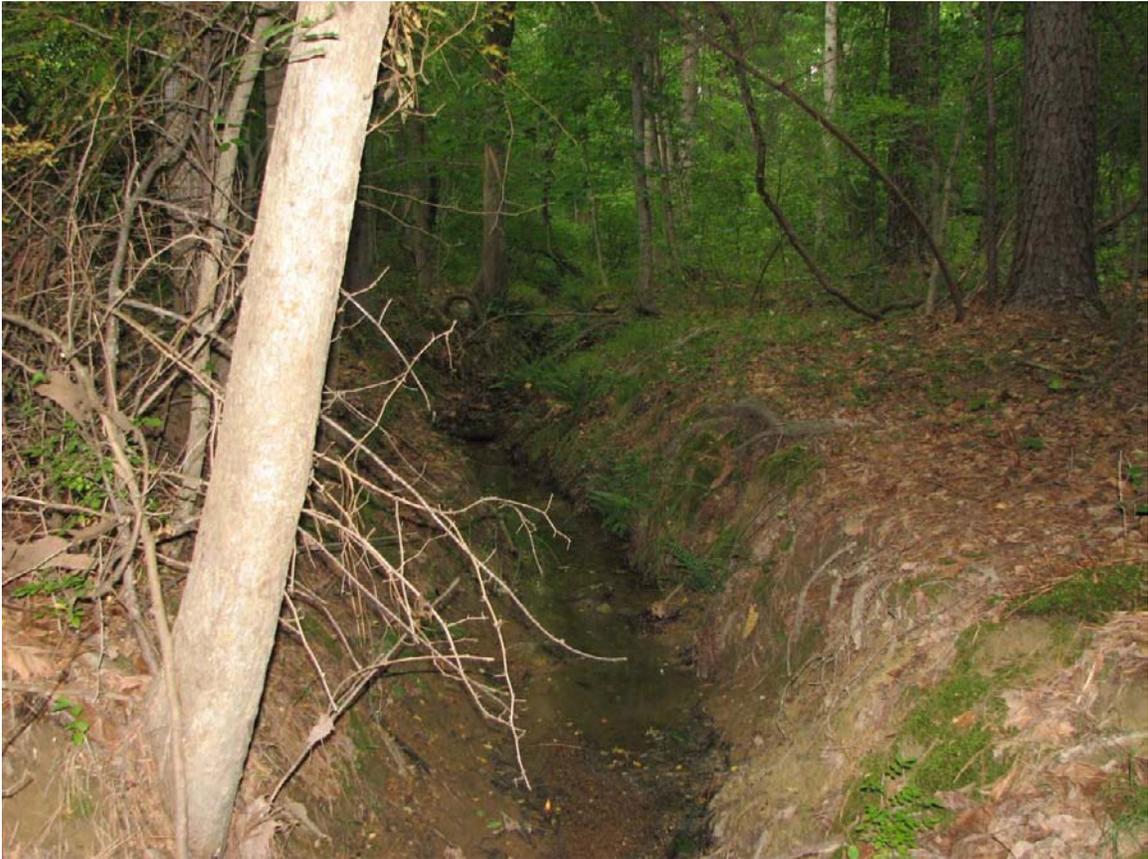
Index Sheet No.: 16
Raw Data Name: IJ 32

Project 16-03 consists of what was observed to be an ephemeral tributary to Jolly Branch that is currently incised and contains a headcut working upstream towards a paved path. The tributary has been channelized into a ditch, and has a concrete pipe outlet providing stormwater input. The contributing drainage area of this pipe appears to consist of part of the football field at Chapel Hill High School, part of the practice football field, and a portion of the student parking lot. These impervious surfaces are likely contributing pollutants, as well as the nutrients from the fertilization of the football fields, into the ephemeral tributary and into Jolly Branch. The confined ephemeral drainage feature does not have a floodplain or enough surface area to prevent erosion, so bank erosion will continue.

Water quality treatment and quantity treatment at Site 13 could be provided by the construction of a small bio-retention area in-line with the tributary. A bio-retention area is preferred over another structural BMP here because of the lack of available space for construction, and the relatively small drainage area. The tributary on which the bio-retention area should be located was observed to be ephemeral, however further verification will be needed to ensure that an in-line BMP can be placed along it. Runoff volume will be stored in underground storage, reducing peak runoff rates and potentially augmenting baseflow.

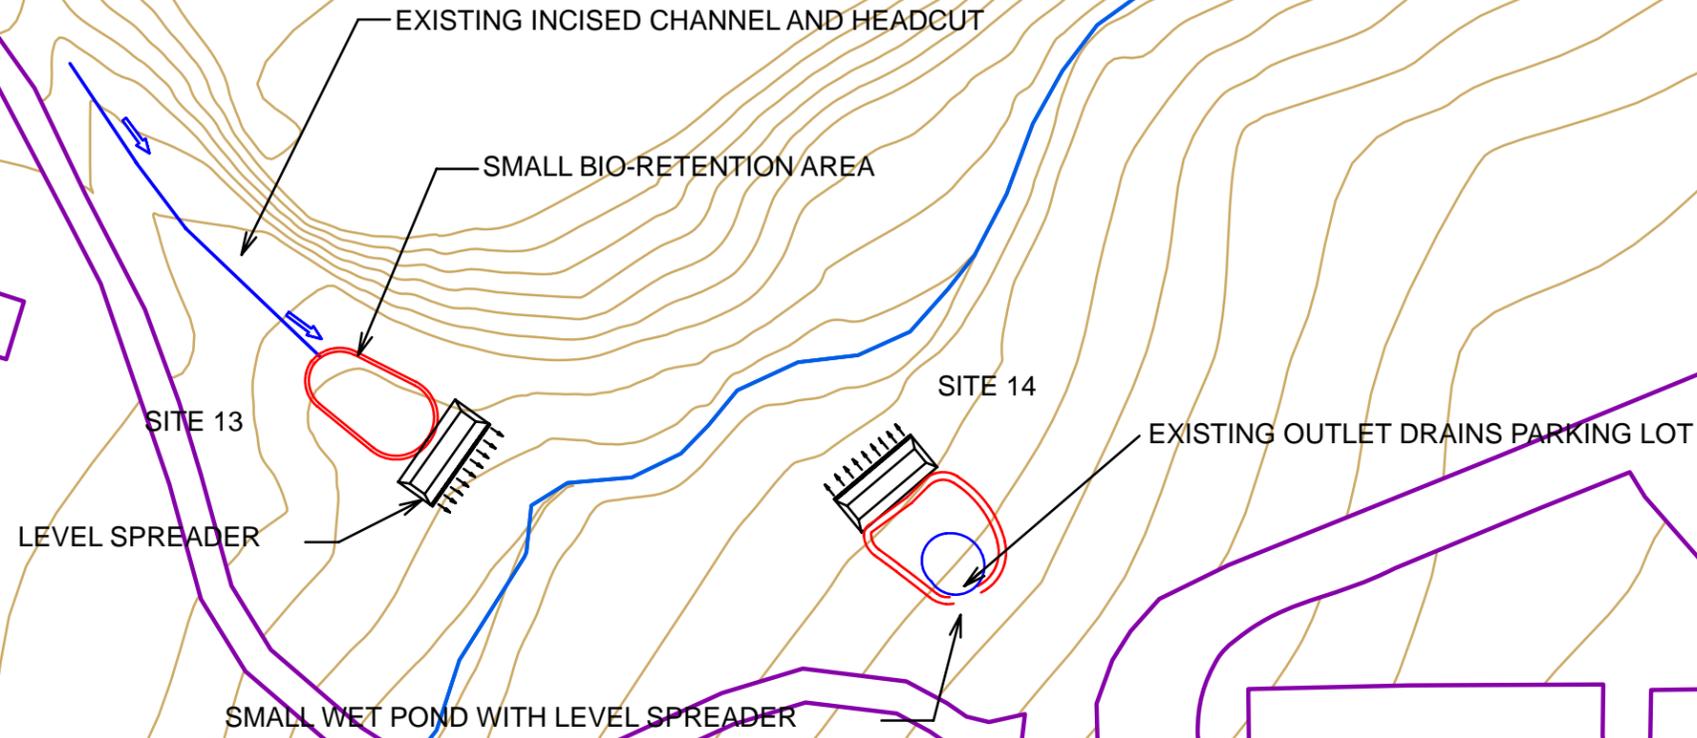
CONCEPTUAL PLAN VIEW BOLIN CREEK WATERSHED Geomorphic Analysis and Potential Site Identification For Stormwater Structures and Retrofits

EXISTING INCISED CHANNEL AND HEADCUT

SMALL BIO-RETENTION AREA

LEVEL SPREADER

SMALL WET POND WITH LEVEL SPREADER

EXISTING OUTLET DRAINS PARKING LOT

An under-drain should be used with the bio-retention area, as the in-situ soils are most likely too impermeable to allow infiltration into the surrounding soils. This under drain or pervious drain layer will allow each successive cell to discharge to the next over extended periods of time.

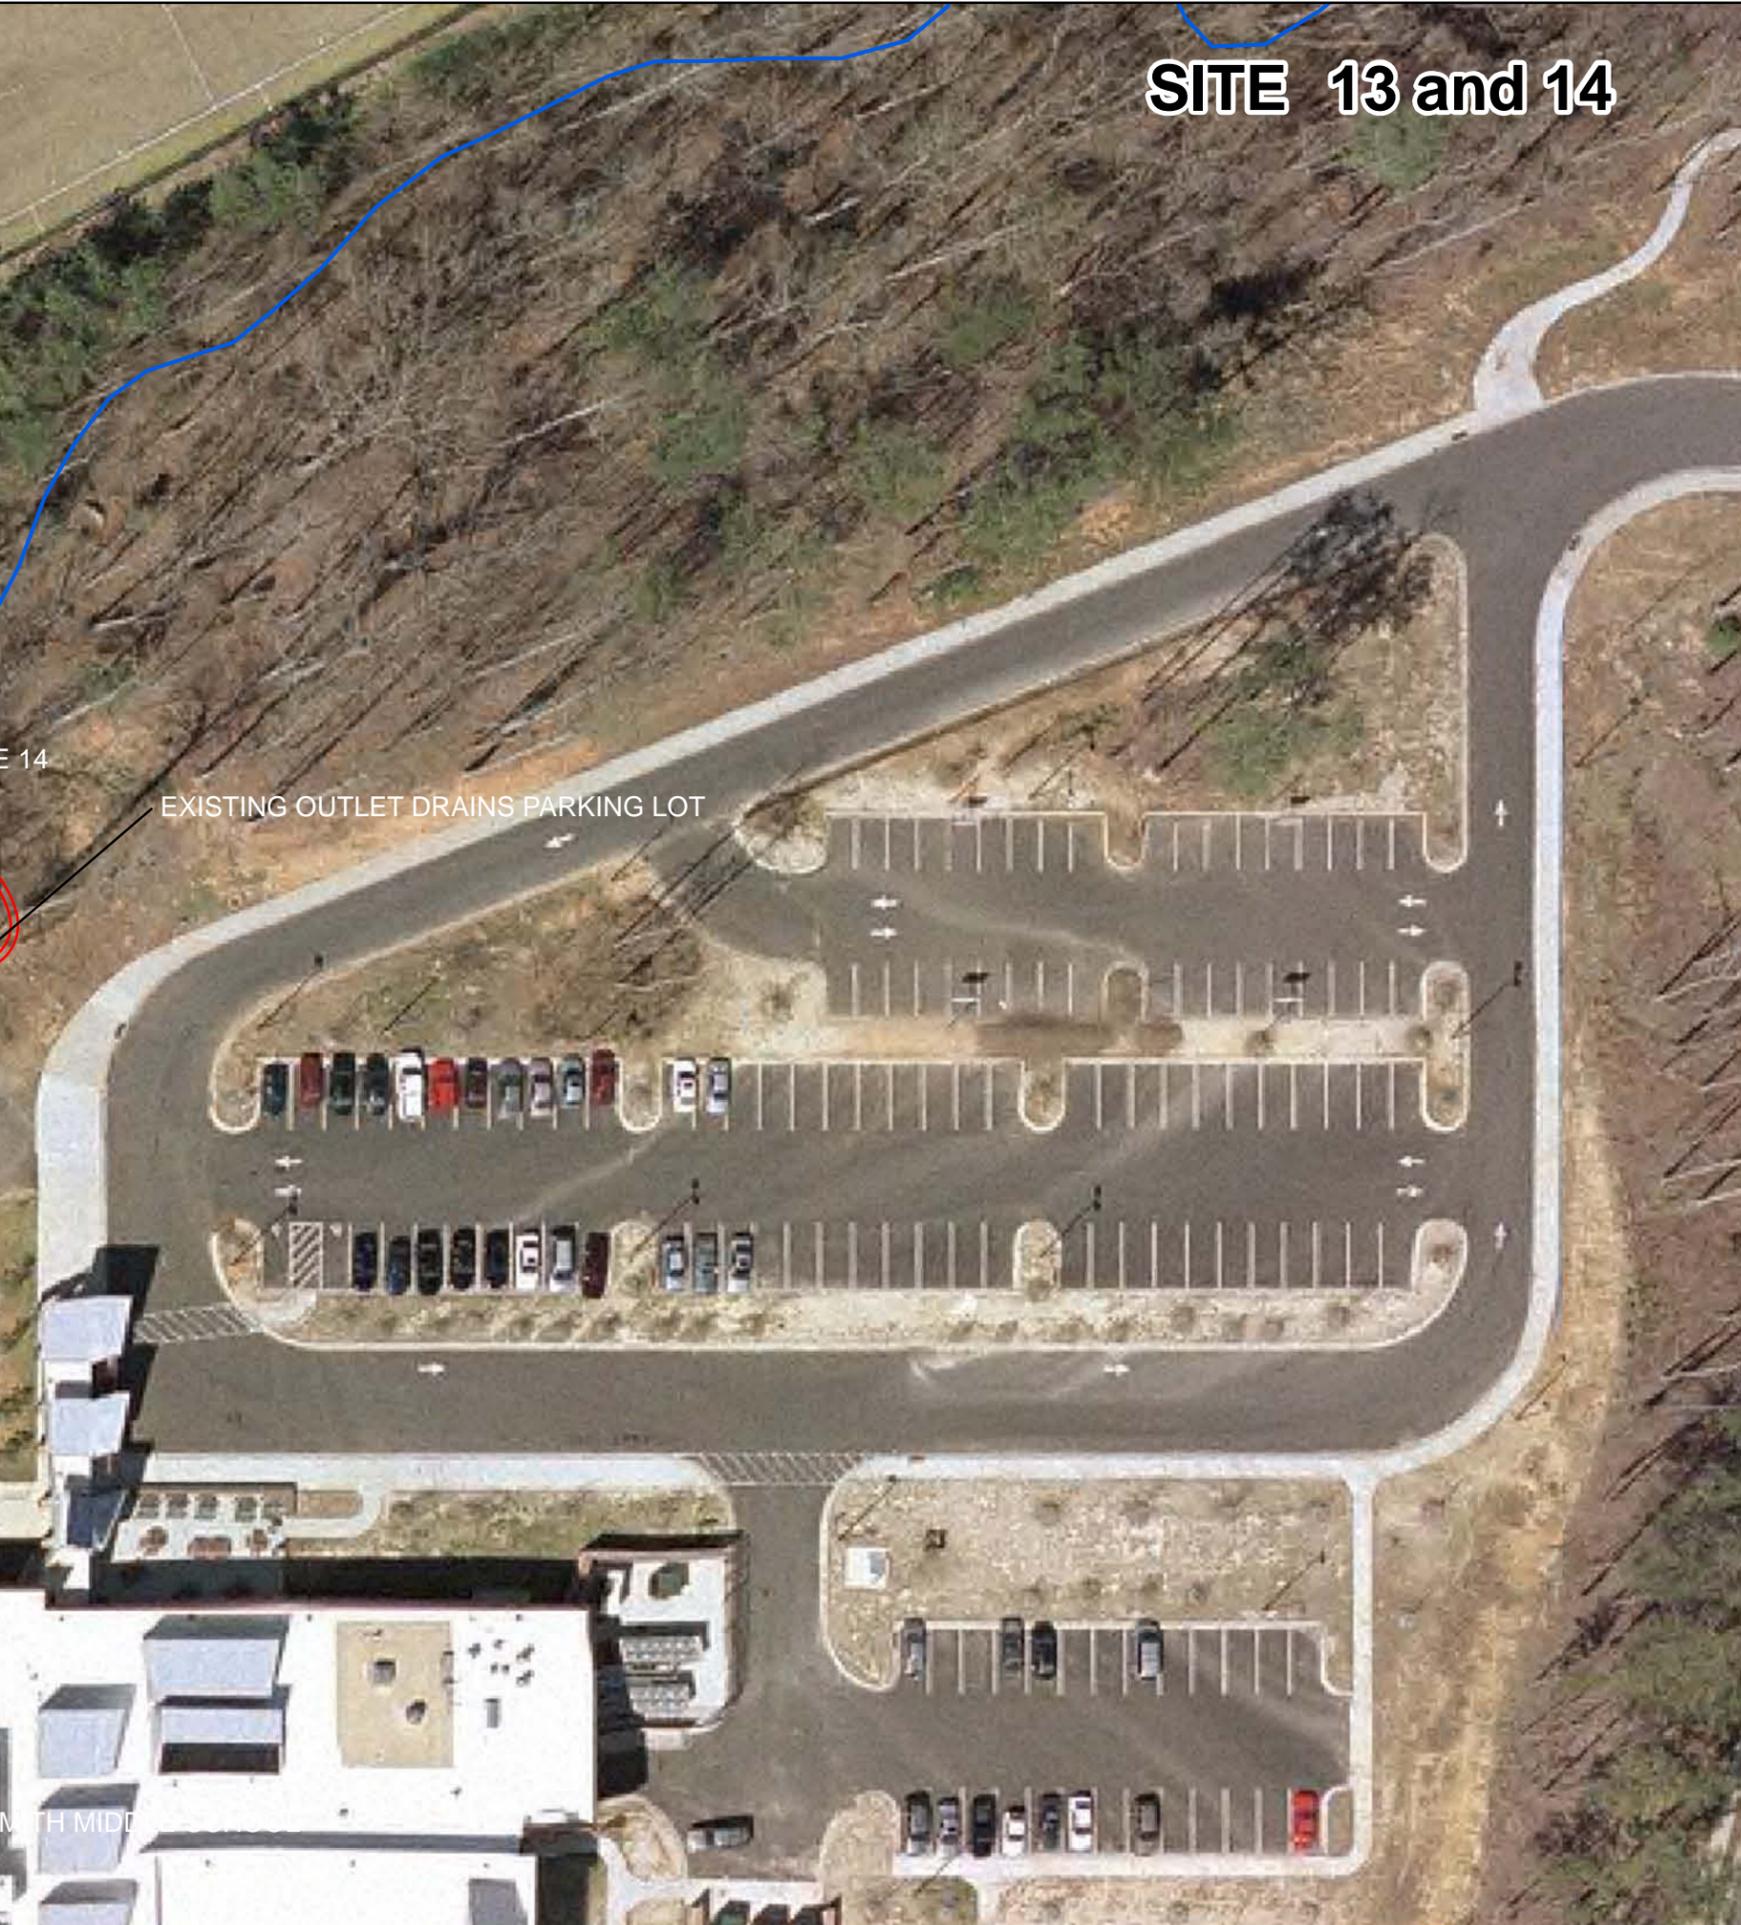
AERIAL PHOTO VIEW
BOLIN CREEK WATERSHED
Geomorphic Analysis and Potential Site
Identification For
Stormwater Structures and Retrofits

SITE 13
