# Fordham Boulevard Trail Assessment Report

The Fordham Boulevard Trail is in Chapel Hill, North Carolina, along Fordham Boulevard (US 15-501) from Cleland Drive to Ridgefield Road. The trail is approximately 1,700 linear feet and includes one timber boardwalk that crosses Bolin Creek near Estes Drive.

Kimley-Horn performed a site visit to the Fordham Boulevard Trail on January 31, 2018 to document the current condition of the trail and existing boardwalk. Throughout the course of the visit, the weather was clear and sunny. Our objective was to determine design deficiencies that do not meet NC Bicycle Program and AASHTO standards, summarize our findings, and recommend design solutions to bring the trail up to NC Bicycle Program and AASHTO standards. Our field evaluation was performed using visual, non-destructive observations of the trail and boardwalk. Our scope did not include materials testing, hydraulic calculations, or structural calculations. A general description, key findings, and photographs are included in this report to provide the Town with baseline information.

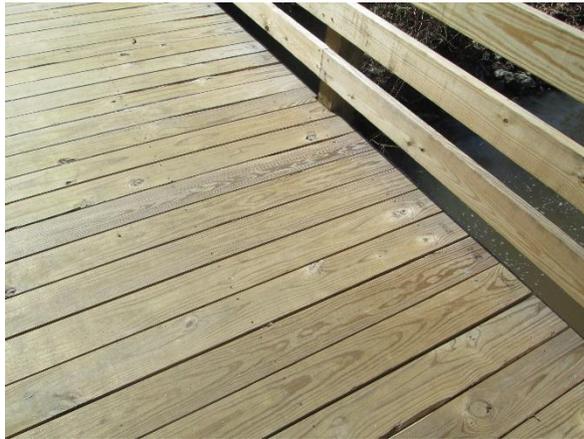
Photo 17  
Timber Decking

- Timber railing and deck have been recently replaced.

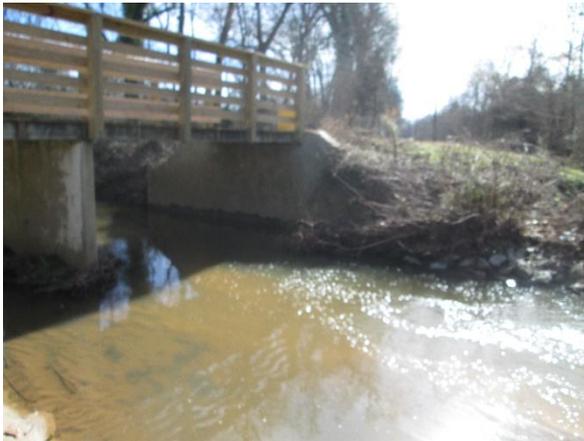
Photo 21  
South End Bent

Substructure appears to be in good condition. However, no rip rap was observed protecting the 3 substructure elements from scour. It is recommended that the Town monitor the progress of any scour and add rip rap to protect substructure as necessary.
